The Great East Japan Earthquake

Report
on the Damage
to the Cultural Heritage

20 November, 2011

Japan ICOMOS National Committee

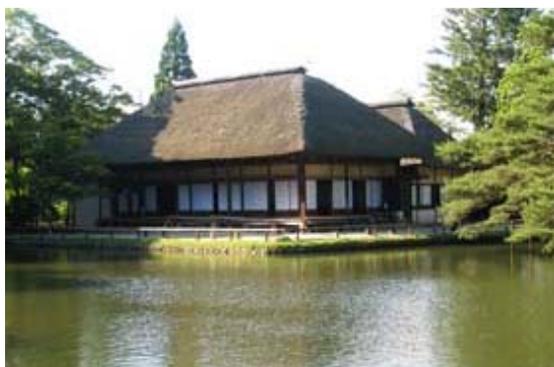
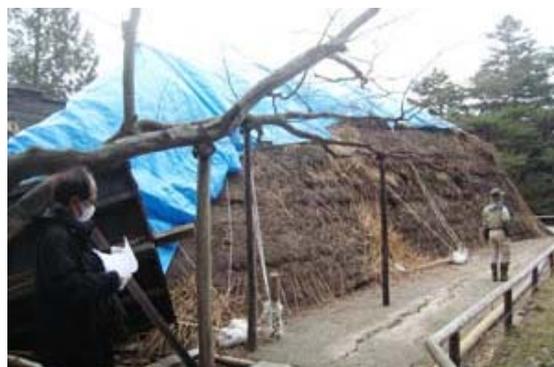
The main building of the old Yubikan (Japan’s oldest school located in Osaki city, Miyagi Prefecture; built in 1691) which is a designated National Historic Site, collapsed (Figure 2.4). It is located in the region with the strongest measured tremor of by the present devastating earthquake. As the main building had little earthquake-resistant elements, it is believed that it was fundamentally lacking in horizontal resistant capacity. This building suffered damage when the Iwate-Miyagi Inland Earthquake struck in 2008.

Figure 2.4 Main building of the historic site, the Yubikan (Left: Before earthquake; Right: After earthquake)

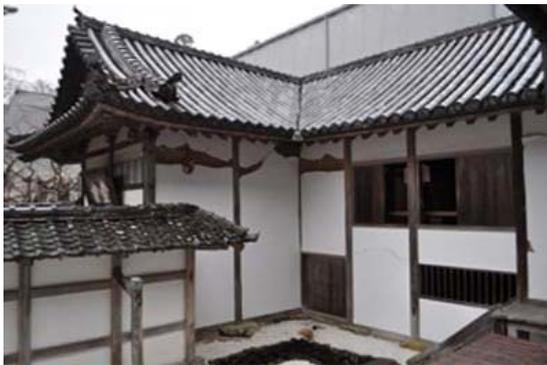
Figure 2.5 The Zuigan-ji temple priest's quarters, which sustained damage to the plaster wall

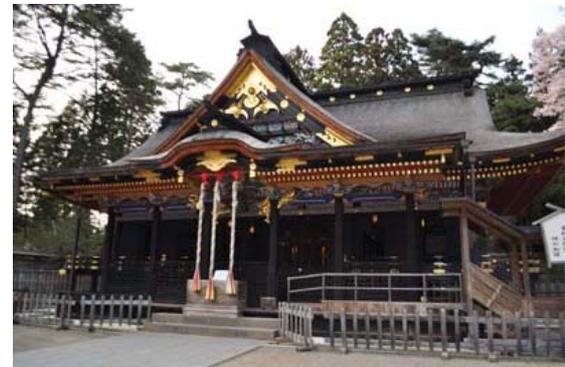
locates in Osaki city, Miyagi Prefecture, was slightly damaged. In this Osaki City, Yubikan completely collapsed as described above. Although this building of Osaki Hachimangu had been partly dismantled and repaired five years before, it was not seismically strengthened. Damage to the Sendai City important cultural property, the Mutsu Kokubun-ji Yakushido (1607), was limited to part of the lath wall falling down.

Figure 2.7 The national treasure, the Osaki Hachimangu Shrine - sustained very minor damage

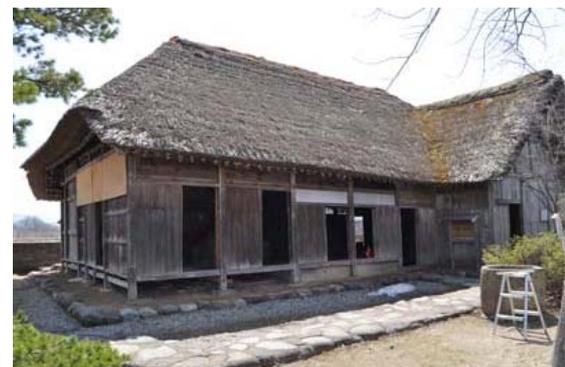
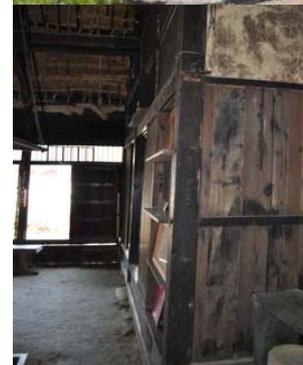
Figure 2.8 The important cultural property, the former Baba Family Residence, which is tilting (Top: Exterior; Bottom: Tilting interior)

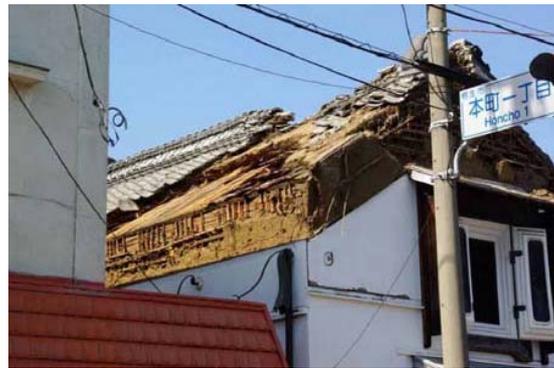
Dozo (mud-wall warehouse) buildings spreading from a wide area from Tohoku to Kanto were damaged. Figure 2.10 shows typical damage to classic *dozo* (the registered tangible cultural property, the Mori Goshi Gaisha storehouse). The eaves have collapsed and the earthen wall is cracked. Figure 2.11 is an example of damage in the Tohoku region (Sekinoichi Shuzo,

Figure 2.10 Damage to classic *dozo* (mud-wall warehouse) - the registered tangible cultural property, the Mori Goshi Gaisha storehouse

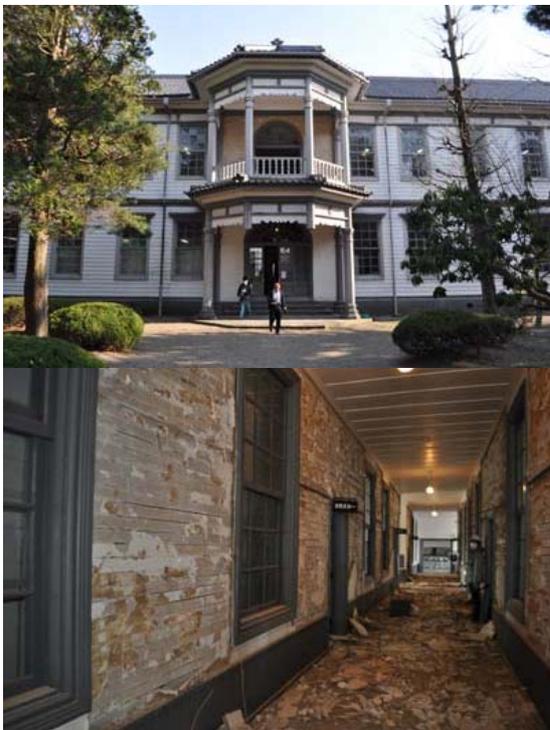
Figure 2.9 Damage to the important cultural property, Fukushima Prefecture Jinjo Junior High School (Top: Building exterior; Bottom: Peeling lath wall)

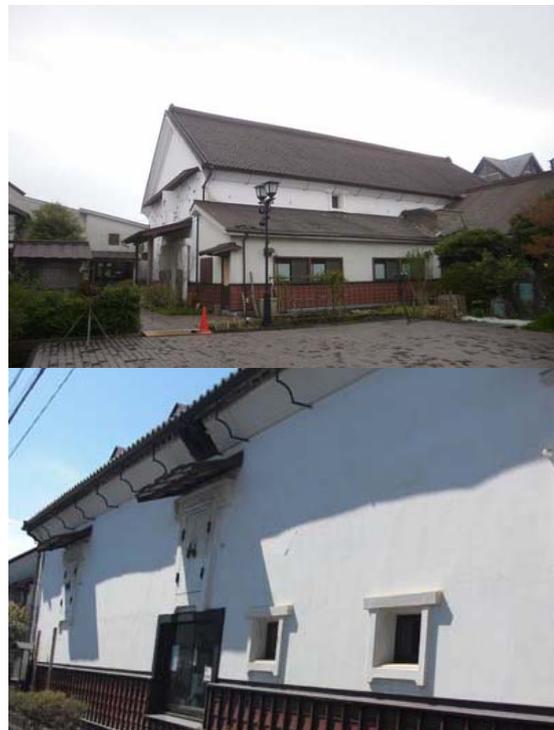
tori-kura (walk-through storehouse)). The building is slanted and the eaves are damaged. It was renovated by a *sake* brewery to be used as a *dozo*, and is a registered cultural property that was still being put to use. This heritage structure is a registered tangible cultural property and is still being put to use. Devising measures to keep utilizing it while securing safety have become a challenge. The registered tangible

Figure 2.11 The registered tangible cultural property, Sekinoichi Shuzo and damage to the *tori-kura* storehouse (mud-wall timber structure)

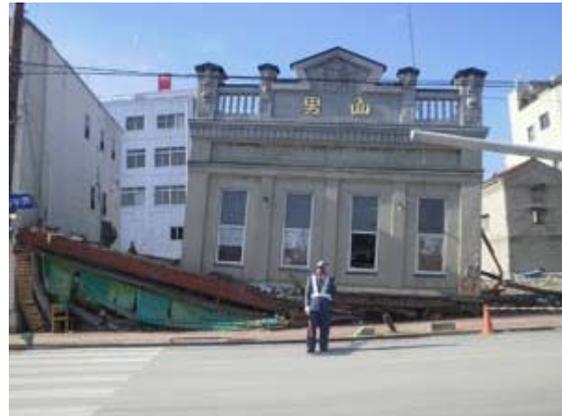
Figure 2.13 Tsunami-caused damage to the registered tangible cultural property, the Otokoyama Shuzo original store

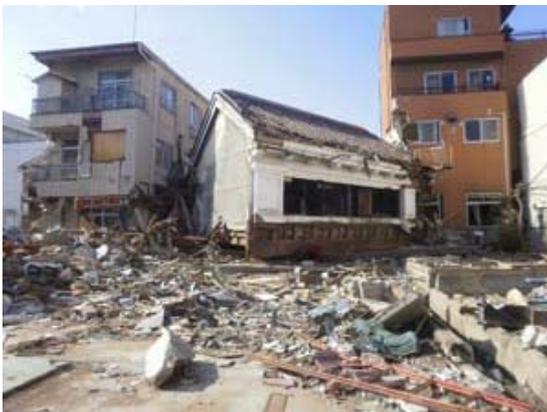
Figure 2.12 The registered tangible cultural property, the Kakuboshi shop, which was swept away by the tsunami

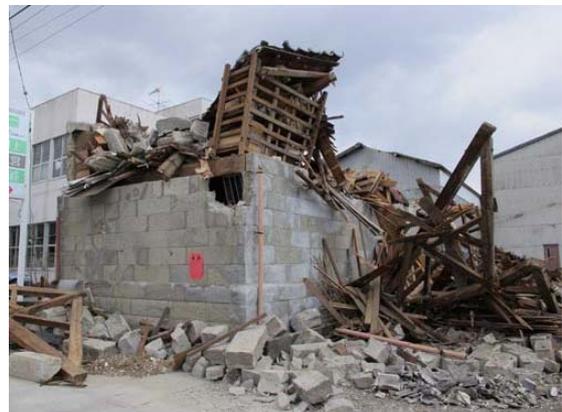
Figure 2.14 Collapse of stone storehouse in Makabe, an Important Preservation District for Groups of Traditional Buildings

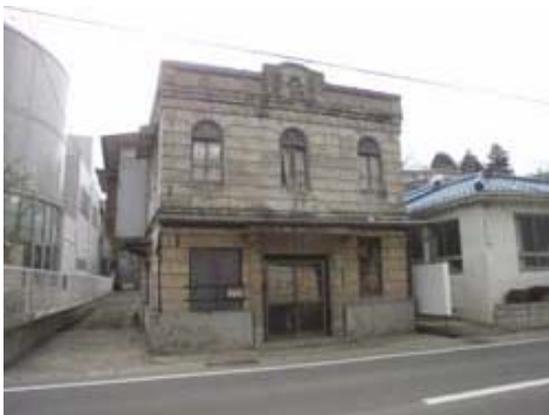
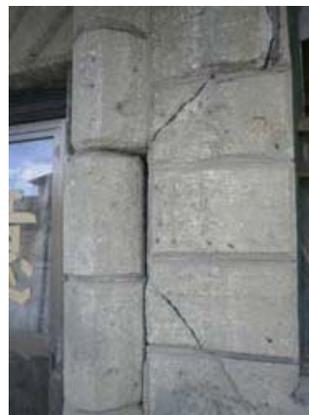
damage such as horizontal cracking starting from the entrance due to ground motions (Figure 2.15). According to a survey of the exterior, damage was concentrated in the two-story building section. The district where the Takahashi Family Residence is located was submerged under a tsunami approximately 1m deep, but the damage was caused by the earthquake ground motions. The dimension of piece of stone was 87cm x 29cm x 27cm. Cement mortar was used for the joints. The building was unreinforced structurally, but according to a survey of buildings (Kesenuma City buildings built with similar stone materials) that collapsed due to the tsunami, it seems that cramp steel bars approximately 6mm in diameter were inserted to connect stones. This implies necessity for conducting more detailed surveys of damage and reinforcement in the future. There are also *machiya* (traditional wooden townhouses) style buildings surrounding in the area surrounding the Takahashi Family Residence. While some buildings have stone walls between adjacent residential buildings, no damage was sustained by the strong ground motions. At the Hashino Blast Furnace (Kamaishi City, Iwate Prefecture, 1958), which is Japan's oldest western-style blast furnace and a nationally-designated historic site, there was damaged such as displacement of the ashlar stone that made up the furnace (Figure 2.16). Generally, many stone constructions, such as stone lanterns vulnerable to ground motion, were affected by the strong ground motions. In the case of the Shiogama Shrine in Shiogama City where strong 6 on the JMA intensity scale was recorded, wooden important cultural property structures including the Migimiya (right shrine) main hall, the Hidarimiya (left shrine) main hall, and the Betsumiya (separate shrine) main hall (beginning of the 18th century) were not affected externally (Figure 2.17), but there was damage to many stone monuments such as stone lanterns. This damage included displaced stones and fallen top stones.

Figure 2.15 Damage to the Takahashi Family Residence, a registered tangible cultural property

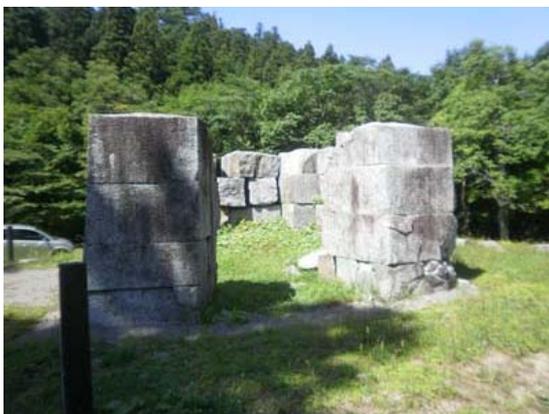
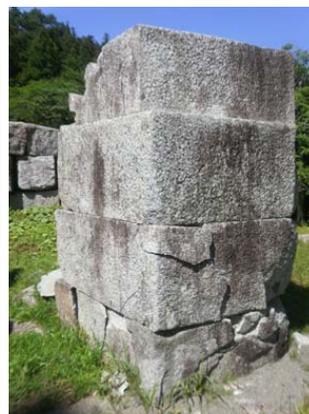
Figure 2.16 Displaced and cracked stone masonry at the Hashino Blast Furnace, a historic site in a Kamaishi City

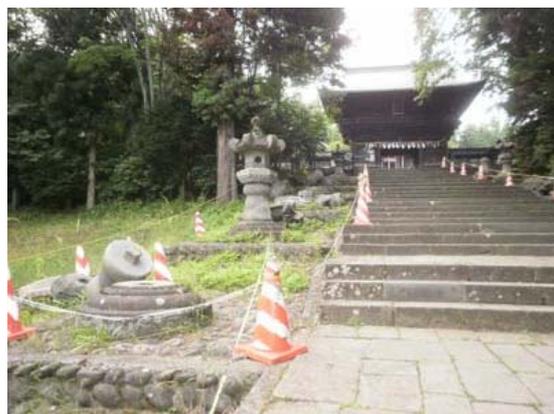
Damage to stone pagodas vulnerable to ground motions could be seen in various regions. Many stone pagodas designated as important cultural property collapsed at the Toshogu Shrine in Sendai City (Figure 2.18).

Figure 2.18 Collapse of stone lanterns at the Toshogu Shrine, Sendai City, an important cultural property

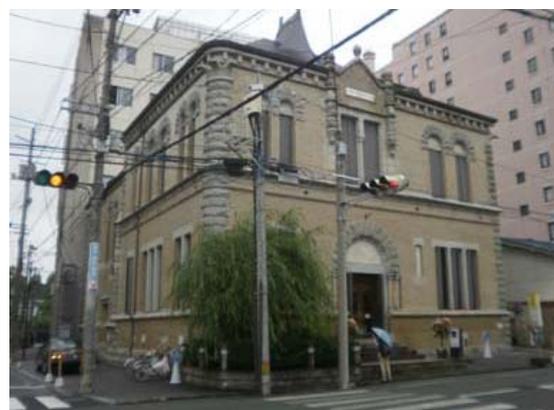
Figure 2.19 Former 99 Bank Head Office, an important cultural property: Minor damage to internal walls and ceiling

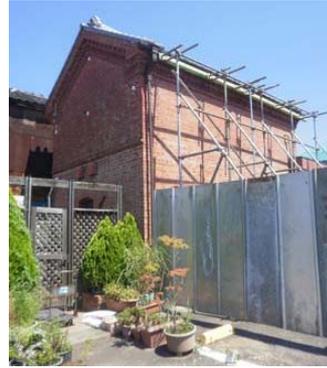
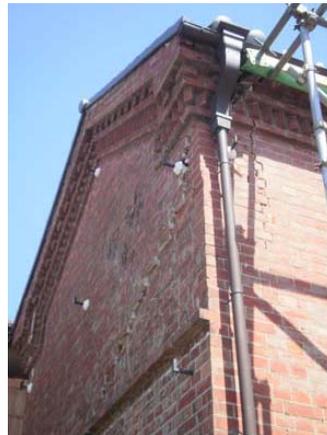
where there are still brick-constructed storehouse buildings from the Taisho era to the Showa era. One of those, the Machikado Kura Nomura brick storehouse, sustained significant damage with cracks appearing in the walls (Figure 2.21). This brick-constructed structure was being used as a cafe before it was damaged by the earthquake. The Architectural Institute of Japan is involved in the conservation of this building due to its historical value, although it is not a designated cultural property. The S kindergarten building in central Mito City, Ibaraki Prefecture is a brick-constructed structure built in 1912 (undesignated), and in recent years it has undergone reinforcement work. However, as shown in Figure 2.19, inplane shear cracks have appeared in the English bond brickwork wall, and other major damage has occurred such as the wall collapsing in out-of-plane. This building had been structurally reinforced with a steel frame. Nearby residential housing and commercial facilities were undamaged. The first winery in Japan, the Chateau Kamiya in Ushiku City, Ibaraki Prefecture, is a brick structure that was built in 1903. Designated an important cultural property, it was significantly damaged by this earthquake (Figure 2.22).

Figure 2.21 Disaster-affected brick storehouse, the Machikado Kura Nomura (Top: Building exterior; Bottom: Cracked gable wall)

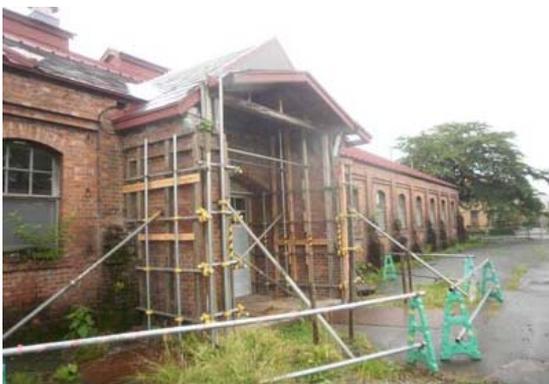
Figure 2.20) is a brick structure that has been nominated as a modern heritage, but cracks appeared in the entrance area and emergency measures are being taken to prevent the building from collapsing. In Sendai City, the 3-story brick architectural museum in the Tohoku University campus (before 1910) sustained damage such as cracks in brick walls. In Fukushima City, the brick-constructed and registered tangible cultural property, the United Church of Christ in Japan, was damaged by the disaster. It was subsequently demolished and removed by the owners due to concerns for the safety of the church goers¹⁾. In North Kanto, there was no structural damage to the timber framed brick structure, the former Tomioka Silk Mill, which is registered as an important cultural property. The Kiryu City-designated cultural property, the Yurinkan, sustained some damage to the roof tiles and the brick wall was slightly cracked. In Tsuchiura City, Ibaraki Prefecture, there is a district

Figure 2.20 Disaster-affected modern heritage, the former covered parade ground building

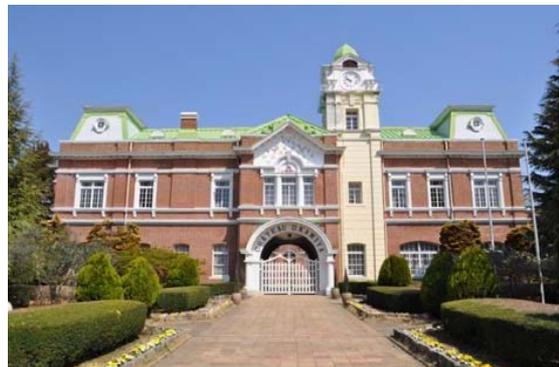
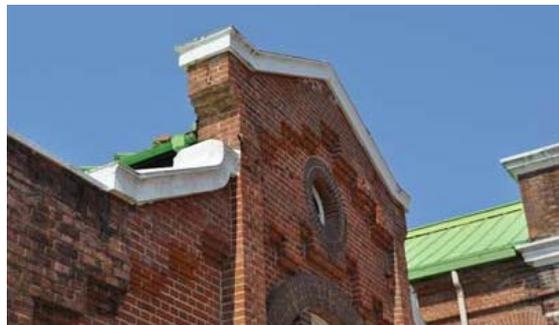
Figure 2.22 Disaster-affected Chateau Kamiya winery building, an important cultural property (Top: Building exterior; Bottom: Cracked gable wall)

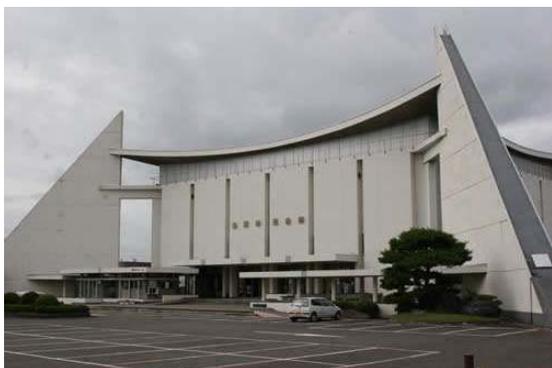
Figure 2.23 Furukawa Civic Hall which underwent damage to its non-structural components (from Furukawa city homepage³⁾)

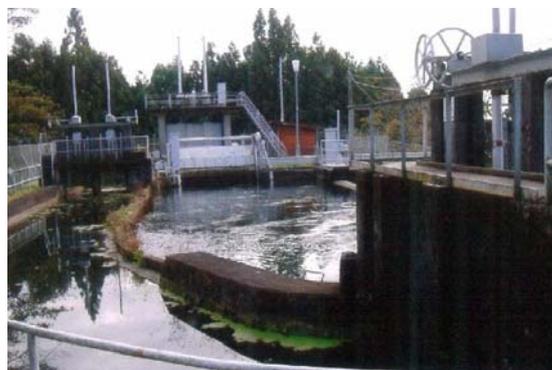
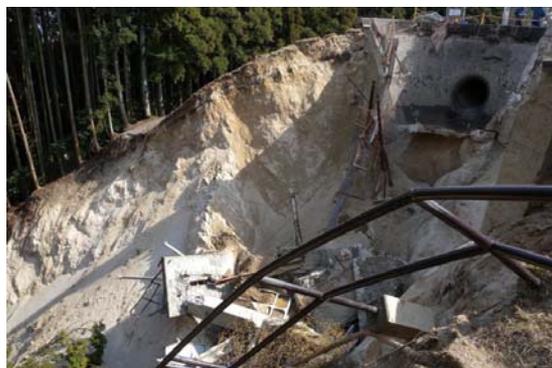
The Ishioka No.1 Power Plant in Ibaraki Prefecture is a conduit type power plant that was completed in 1911 and is in operation even today. It was designated as a nationally important cultural property in 2008 for its high value in terms of Japanese industrial technology, and because it was the first facility to make use of reinforced concrete technology in Japan. It consists of 10 places: a diversion weir, grit chamber, No.1 and No.2 aqueduct bridges, water tank, water tank spillway, pressure-controlled tank, main building's dynamo room, main building's former transformer room, and the main building's switchgear room. Of these, the water tank collapsed three and a half hours after the earthquake occurred (Figure 2.24). The structure itself was not destroyed, but the virgin soil that supports the bottom of the tank collapsed and the tank was unable to hold out. Since

Figure 2.24 Ishioka Electric Power Plant (Top: Before earthquake; Bottom: After earthquake) (Ishioka city, Ibaraki Prefecture)

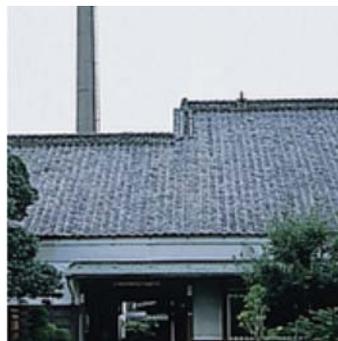
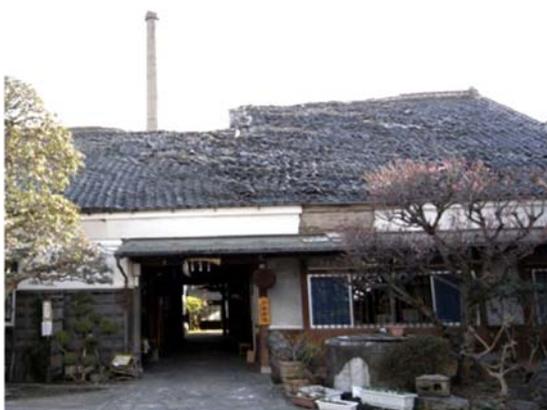
Figure 2.25 A traditional building in Makabe (Top: Before earthquake; Bottom: After earthquake)

Common roof damage was caved-in ridge tiles and falling tiles. Wall damage sustained included cracks and detachment of plaster wall and the collapsed pediment part of stone storehouses. (Figure 2.25, 2.26)

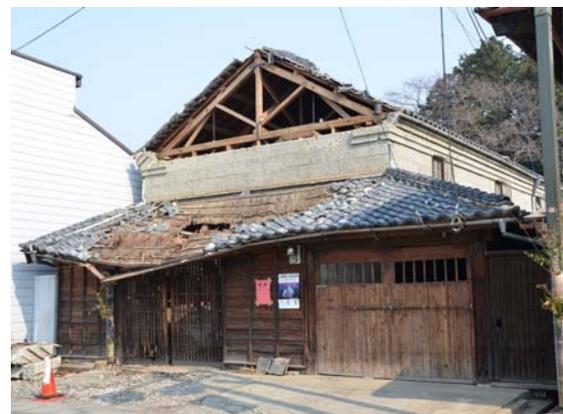
Figure 2.26 A damaged house in Makabe

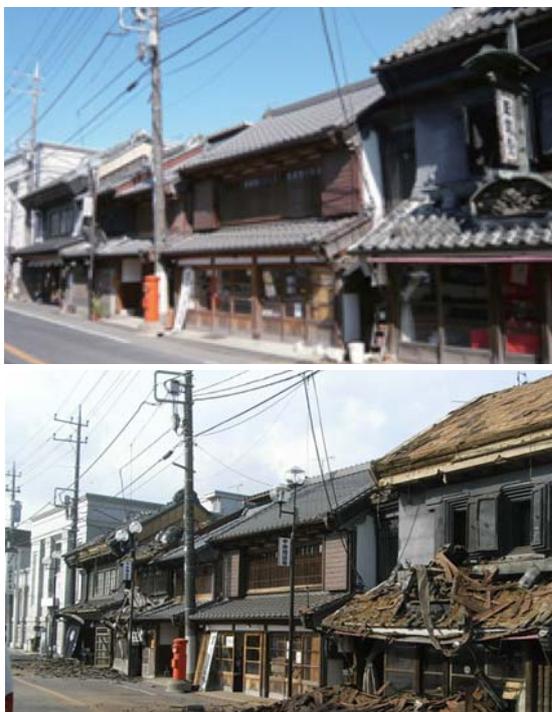
This district is on soft ground and liquefaction has occurred, so the embankment of the river that flows through the center of the district caved-in, and substantial damage was caused by the movement of wood-framing due to uneven settlements along the river. (Figure 2.27, 2.28)

Figure 2.27 Traditional buildings in Sawara (Top: Before earthquake; Bottom: After earthquake)

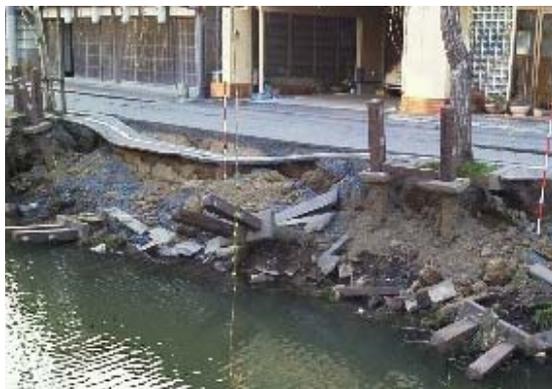
Figure 2.28 Historic riverside damaged

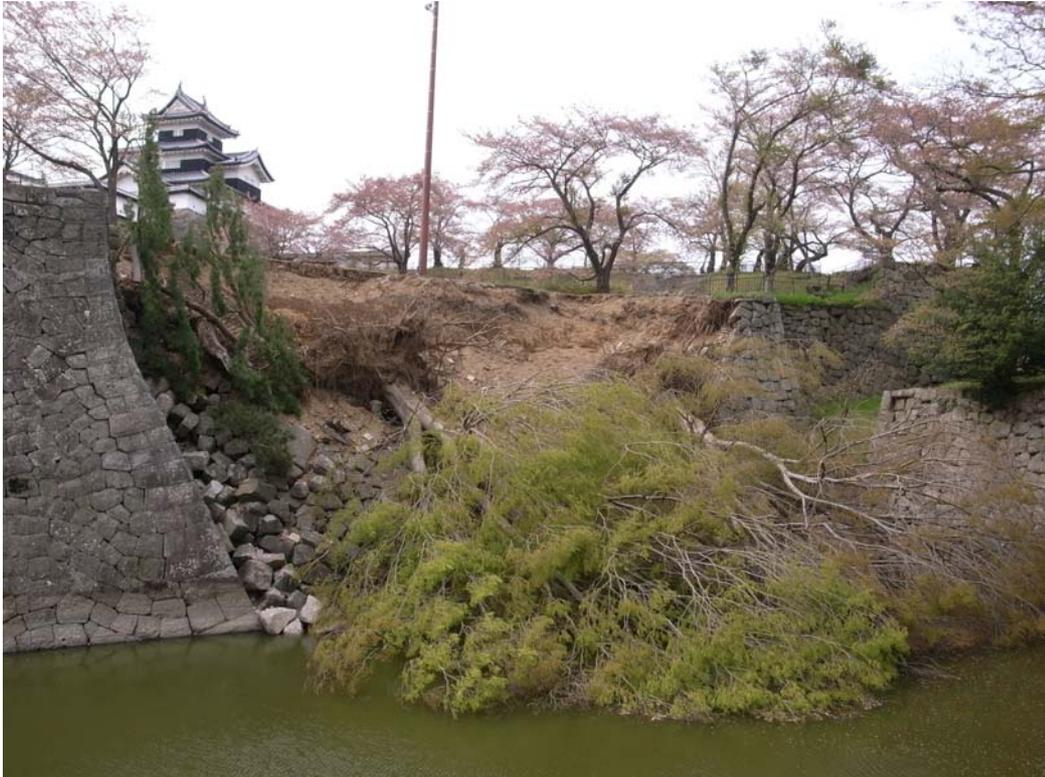
In particular, the masonry walls of Komine Castle sustained heavy damage, and collapsed in ten places

Figure 2.29 Collapsed masonry walls of Komine Castle

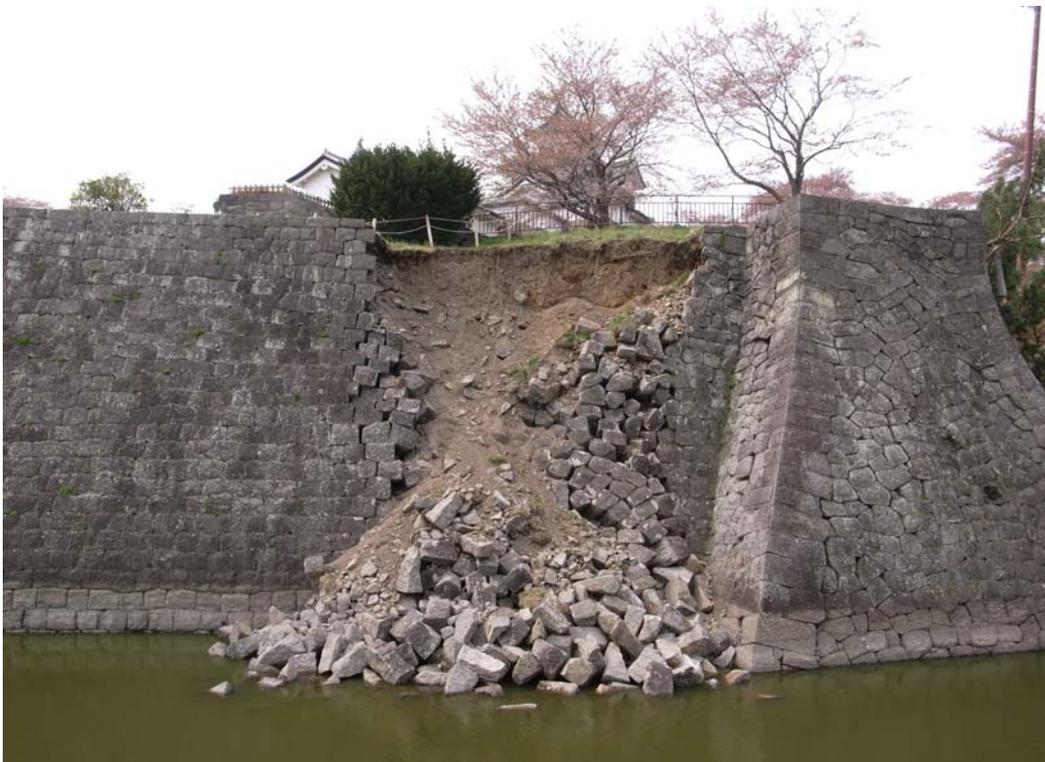
Figure 2.30 Collapsed masonry walls of Komine Castle

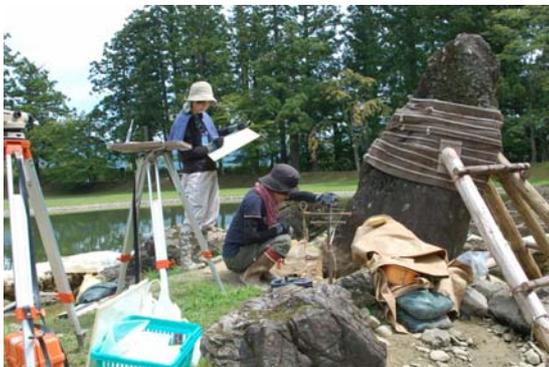
It is said that the Motsu-ji Temple Buddhist monk noticed in May that the standing rocks in the garden's pond were tilting more than before as a result of the earthquake and an aftershock (7th April). In late May, the place in question was looked over, and then fixed

Figure 2.31 Test trench at the base of the standing rocks (Photo provided by the Center of the Cultural Heritage to Hiraizumi)

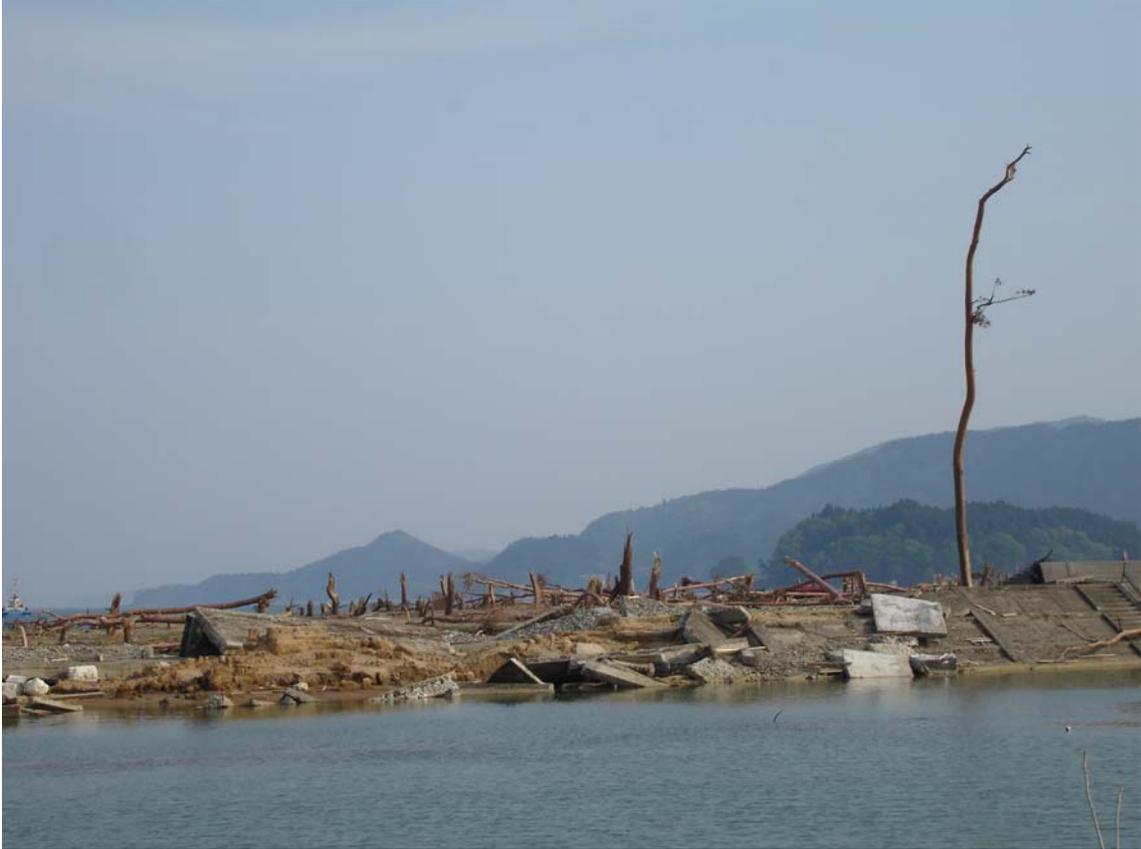
Figure 2.33 Tsunami-swept seashore, Rikuzentakata City

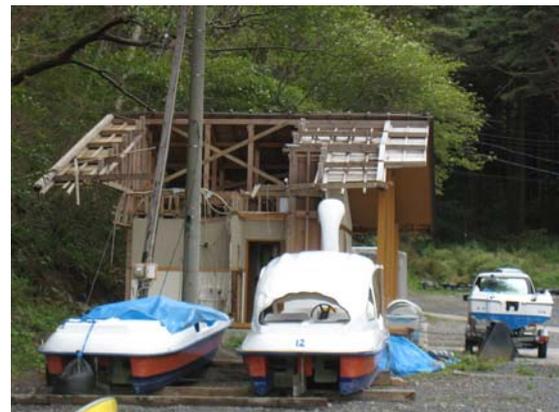
Figure 2.35 Facilities destroyed by the tsunami (Jodogahama)

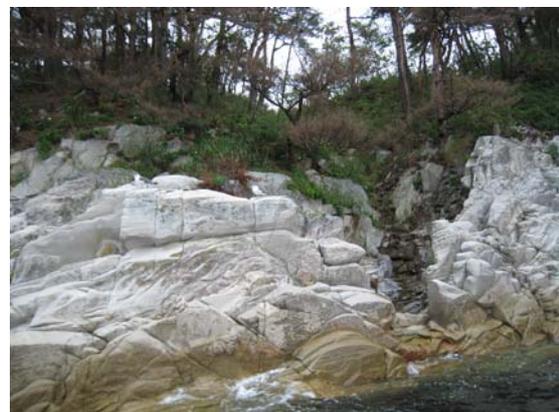
Figure 2.36 The conspicuous dying of pine trees that were engulfed by the tsunami

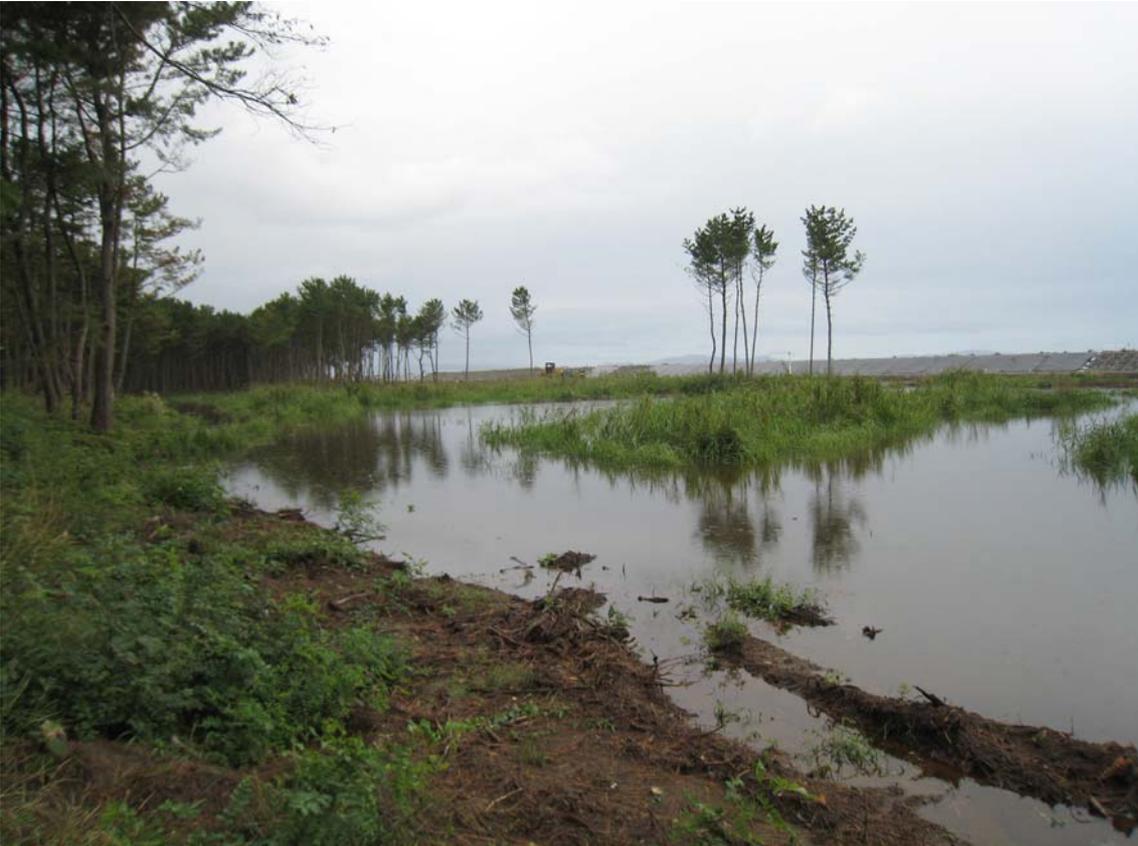
Figure 2.37 Current state of the Matsubara coast in the Nobiru area (half a year after the tsunami struck)

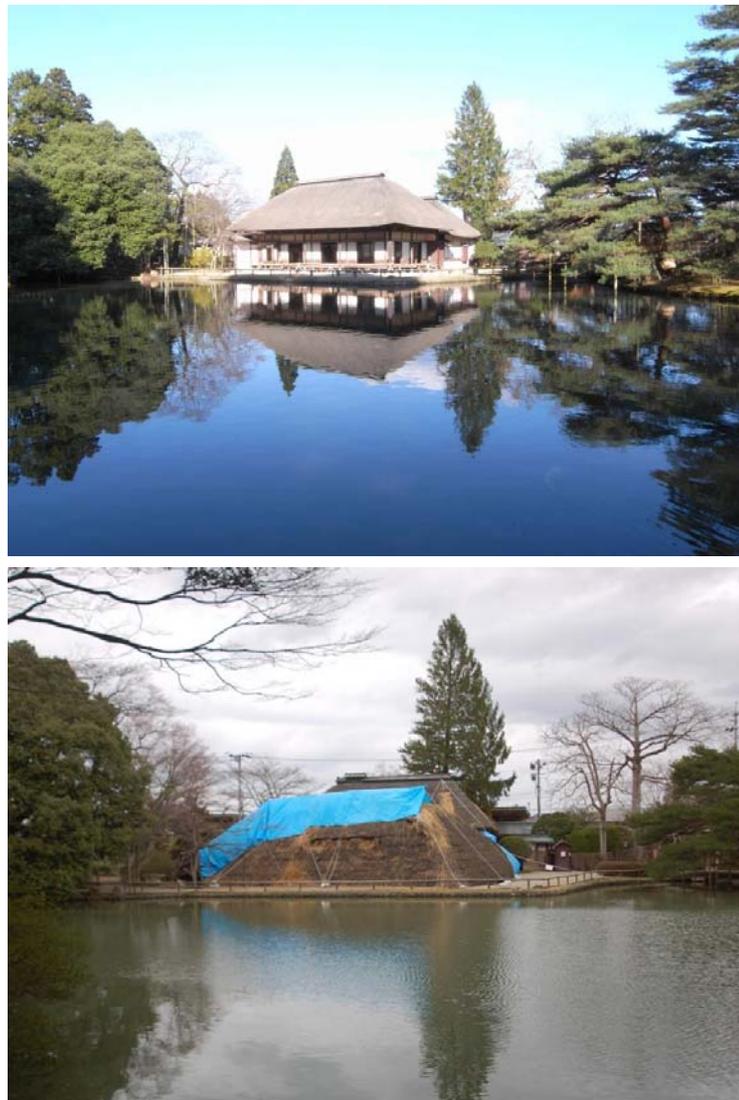
Figure 2.39 Yubikan (Top: Before earthquake; Bottom: After earthquake)

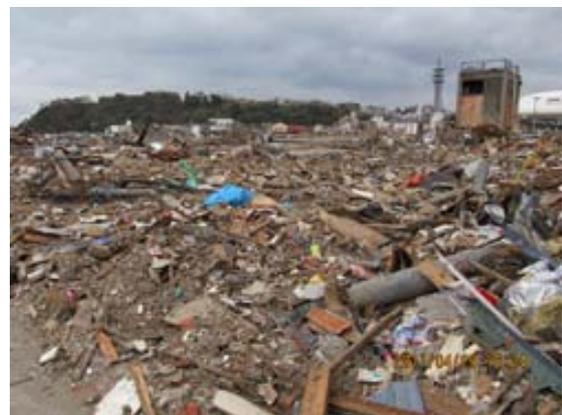
Figure 4.2 Damage caused by the tsunami around the Ishinomaki St. John the Apostle Orthodox Church

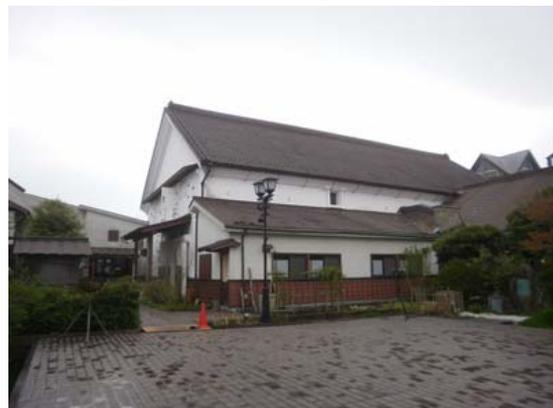
Figure 4.3 Collapsed stone gable wall
