Name of the Monument : Talgashena Ruins
Alternative Name : Sandamini Vehera
Monument Type : *Archaeological/Historical/Religious*
Province : Southern
District : Matara
D.S. Division : Devinuwara
G.N.Division : Gandara Central
Address :

Brief Site Description:

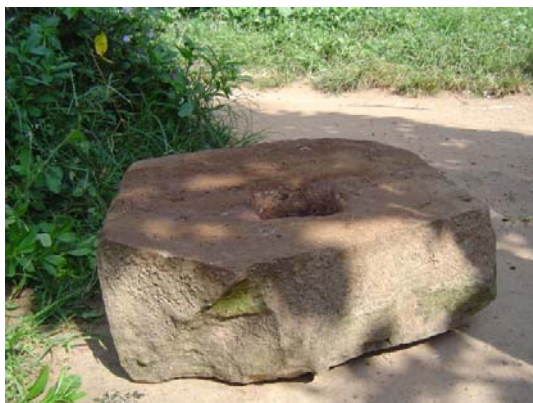
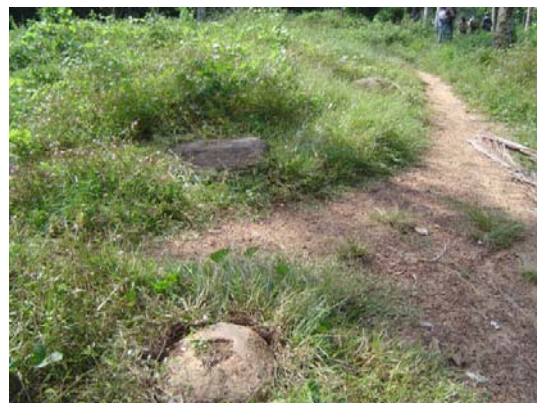
Veheratuduva Talgashena is situated between the Gandara Point and the Dondra Point on a higher land mass that projects towards the sea. It is located about 20-30 meters inland from the sea.

There are stone pillar bases with square slots in the center of the site where the *stupa* is said to have existed. There are at least two such localities where pillar bases representing ancient structures are found here. There are also scatters of pieces of pottery in the area. The villagers claim that some artifacts such as keys were found here. The keys found here were given to the Gandara Vihara.

Approximately 50-60 meters south of the site where the ancient *stupa* is supposed to have existed, is a high level land mass that project towards the sea. There is a timber post similar to those used as street electricity posts. According to the fisherman, a lantern was tied to this timber post and it was used as a local make of a lighthouse in the past. Since this site is situated above 10-15 meters above sea level, the tsunami waves did not affect it.

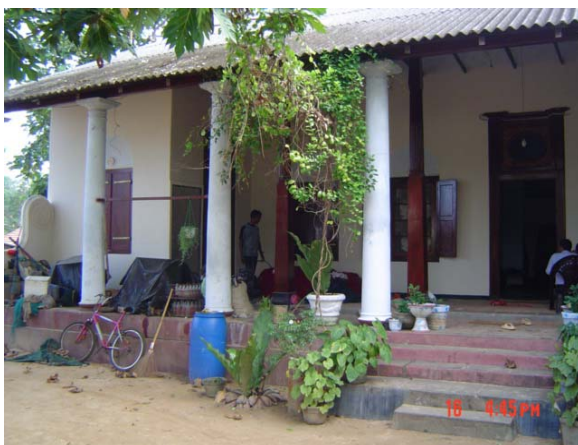
This private house is situated only about 30 meters from the beach and the Gandara Harbour. Though situated so close to the sea, the tidal waves did not encroach this house.

This house originally had a Dutch architectural plan. While this plan has been more or less retained it has been renovated with slight modifications. The plaster of the wall has been replaced as have the original half round tiled roof. The half round tiles are replaced by asbestos. While a part of the original clay tiled floor is preserved in the *zaal* and the interior, the clay tiles have been replaced by cement rendering in places such as the open verandah.

There is a typical round columned open verandah in front. This too has been repaired. A few feet behind these columns are a row of beautifully worked timber pillars cut out of huge single trunks. A timber staircase in the *zaal* leads to the wooden mezzanine. The doors and the windows of this *walawwa* are built of timber. They are in good condition. The main door is said to be a duplicate for the original one that was there.

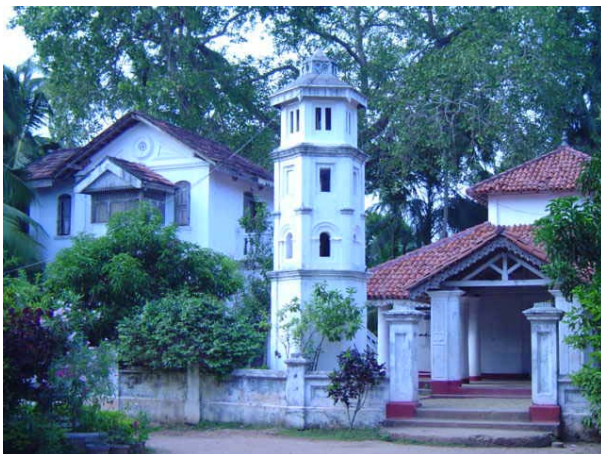
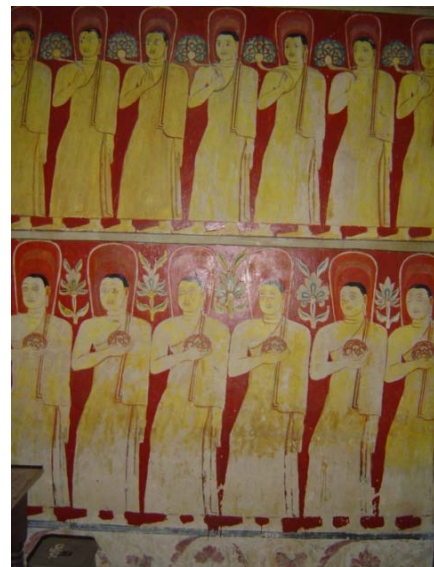
The *walawwa* is a few meters behind this structure. It has a timber pillared open verandah and a *zaal* behind it. A timber built staircase gives access to the timber mezzanine. However, this mezzanine is now deteriorated. A passage from the *zaal* leads to a number of rooms and an open courtyard. There is also a pillared open verandah in the rear side of the building.

The *walawwa* that was at the height of its glory in the past is now badly deteriorated. The foundations of these structures are built of limestone while both cabock and limestone have been used in the walls. Part of the house floor retains the original clay tiles, while some areas are cement rendered. The half round tiled roof is in a state of deterioration. Necessary steps should be taken to restore this unique building.

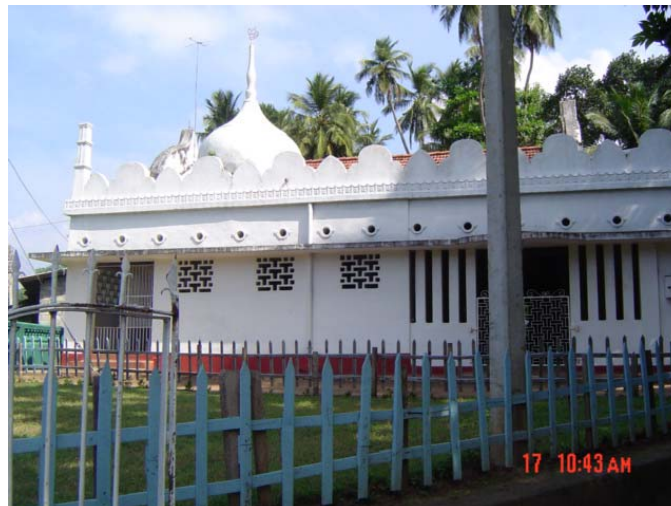
This mosque erected in 1940, is situated totally out of the area of damage from the tsunami and has no special features that are noteworthy.

According to Prematilleke, the present mosque build in 1940 was built on the site of a much older one. But no such traces can be established. Being built about 400 meters from the sea and at a higher elevation, this mosque was not damage by the tsunami. No other noteworthy features are visible.

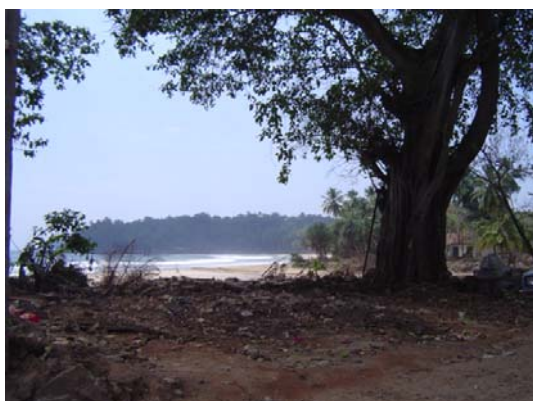
No: M/D/T/78

The site of the totally destroyed Naotunna Ambalama (the resting place) is situated about 25m by the side of the Colombo-Kataragama Road. It is located adjacent to a house cum boutique called Ulukade at Naotunna. The Ulukade itself is badly damaged due to the tidal waves.

According to Prematilleke's report the *ambalama* (24'x15') consisted of two parts: the verandah and an inner room. Even at the time of his recording, the building had been in a state of decay despite several apparent renovations.

It is clear from the rubbles and residue of the foundation and the walls of the building that it had been constructed of limestone. The walls and the roof had been made of half round tiles. According to the owner of the Ulukade (Ulukade Vedamahata), aged about 60 years, the binding material/ mortar of this building was made of banana, honey and limestone. During his childhood there had been a stone water pot (*pantaliya*) filled with water for the use of passersby. No trace of this could be found and the informant himself was clueless about its whereabouts. It had gone out of use and gone missing prior to the tsunami tidal waves.

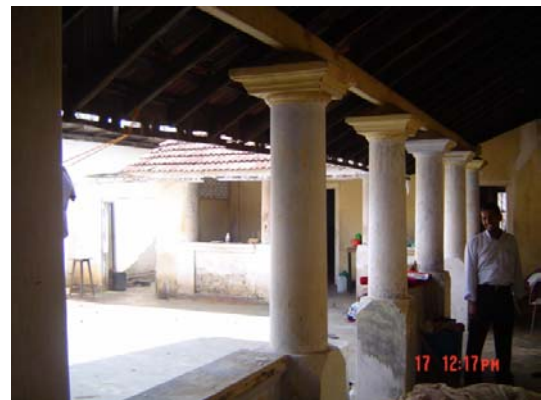
No: M/D/T/79

This house which has architectural affinities to both Dutch and British traditions is located about 300 meters inland. The interior of the house is approached by a portico and a verandah. There are two rooms at each end of this verandah. A timber mezzanine makes the *zaal* and the adjacent rooms a two storied building. A timber staircase facilitates access to the first floor. There is a round pillared and half walled verandah in the rear of the house. A row of wing rooms extend to the backyard at the right side. Brick walls have pre-tsunami minor cracks and bear slight plaster damage. The Calicut tiled roof is in good condition. The cement rendering floor bears some damage but not due to the impact of the tidal waves. The damage to the timber doors are about 50%. The timber lattice work in the front verandah and the portico is destroyed, but prior to the waves.

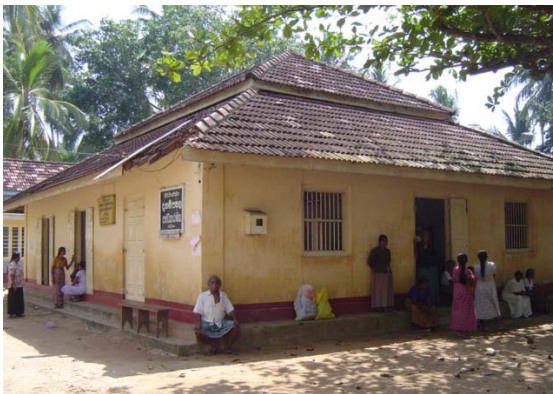
NO: M/D/NS/80

Though situated on the beach itself, this monastery has received only minimal intervention by the waves. It was built in 1910. However, the oldest building of the temple had been destroyed prior to the tsunami. The *dharmasala* and other buildings are from much later periods. There is some minor damage to the doors of the *dharmasala*, but not of any architectural /archaeological significance.

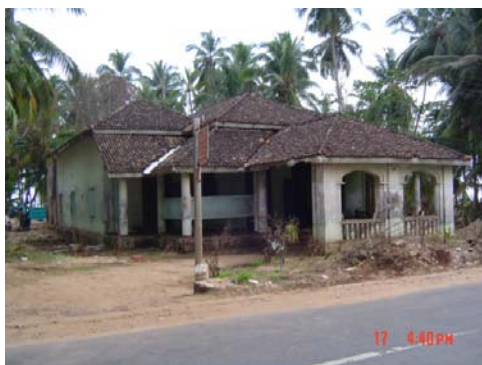
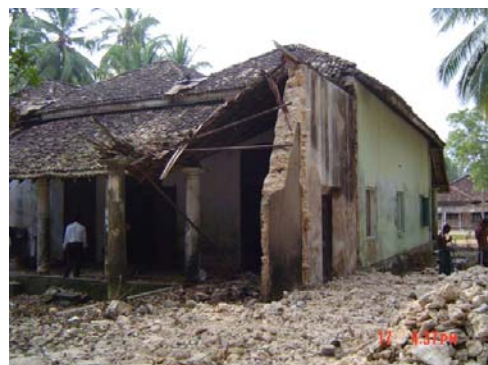
This private house which has suffered considerably due to the tidal waves is situated about 100 meters from the sea. According to the owner, this house is contemporary to the Abeydheera *walawwa* and is about 115 years old. Four generations have passed since the original construction. The damages to the limestone foundation are about 30%. However, the effects of natural decay are more severe than the tsunami damage. The extent of the cracks on the limestone walls are about 10%. The timber and glass doors are the most affected elements in the house (80%). Minimal damage to the windows is visible. The roof that is sheltered in Calicult tiles is partly damaged (20%). This should be repaired without any delay.

The foundation and the walls of the building had been constructed of limestone, while half round tiles are used as roofing. The house floor is made of both clay and cement tiles.

The rear side of the building faces the sea and accordingly the maximum destruction is seen on this side. The rear side left and right rows of rooms - the rear side left and right wing rooms – were completely destroyed by the waves. Almost all the timber doors and windows are destroyed or badly damaged. The timber lattice work of the front verandah is also damaged. Except for the front, the boundary wall is also completely destroyed. The doors and the windows are completely destroyed or badly damaged. The house owners were not present during our investigation and we could not access the damage to the furniture and other belongings of cultural, historical, architectural importance.

No apparent structural damages have happened to the remaining part of the building and therefore the building is structurally, stable and could be restored. However, due to the impact of salt water, the plaster may come off the walls. There is pre-tsunami and tsunami damage to the house floor as well. The roof is in a state of decay and requires repair. The sandy house garden is vulnerable to sea encroachment and soil erosion.

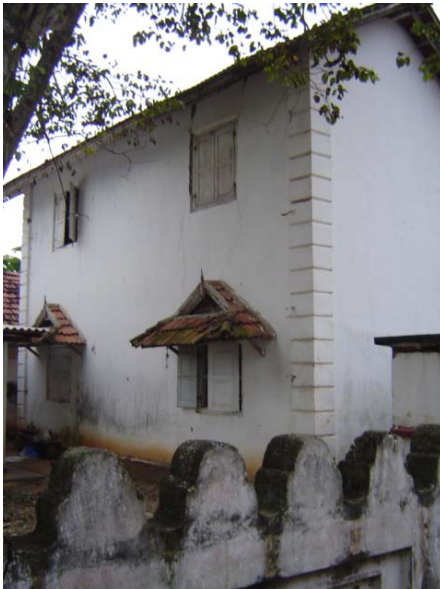
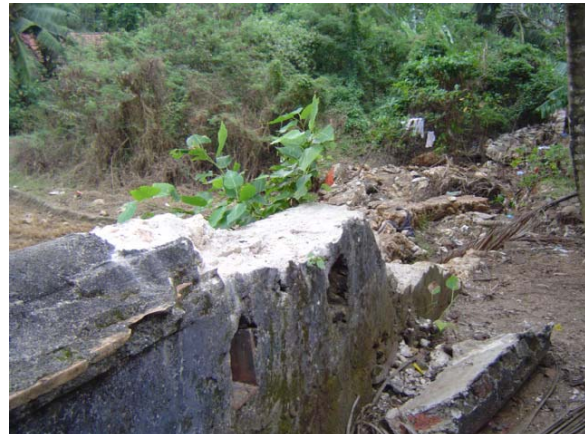
This *vihara* is situated approximately 300 meters inland. The damage due to the tsunami is confined only to the destruction of the boundary wall. The temple was built in 1853 AD (2421 Buddhist era and 1798 Saka era). The paintings of the *vihara* were painted in 1878 and 1948. Antiques such as bronze and limestone Buddha statues and stone basins/water pots are found in the temple.

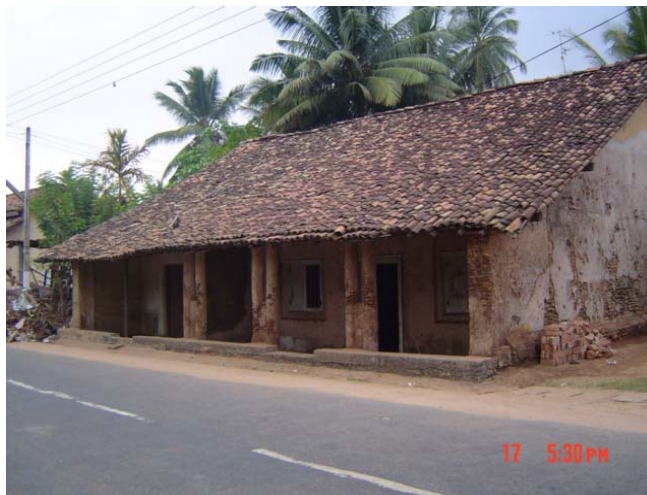
This structure is situated about 30 meters in land. It is divided into two parts by erecting a partition wall. While one of the parts has retained its original character, the other part has being modified damaging the archeological value. There is a round doubled columned verandah in front. These columns are badly damaged from exposure to the close sea breeze conditions. One of the columns has been slightly moved out of its original place by the force of the sea waves. The wall built of bricks and limestone is severely deteriorated. The plaster is very fragile and tends to come of the wall (extent of the damage 90%). Replacing the plaster of the entire structure is necessary.

The half round tiled roof is also decayed and rain water easily penetrates though the roof. Therefore, it is necessary to re-do the roof as well. Approximately 50% of the timber built doors and windows are damaged /destroyed by the tidal waves. The house floor is cement rending .There is a timber mezzanine above the *zaal* and some rooms. It is reached by a wooden staircase. Urgent attention should be paid to restore this building. This structure is marked to be removed by the RDA and necessary steps should be taken to protect it.

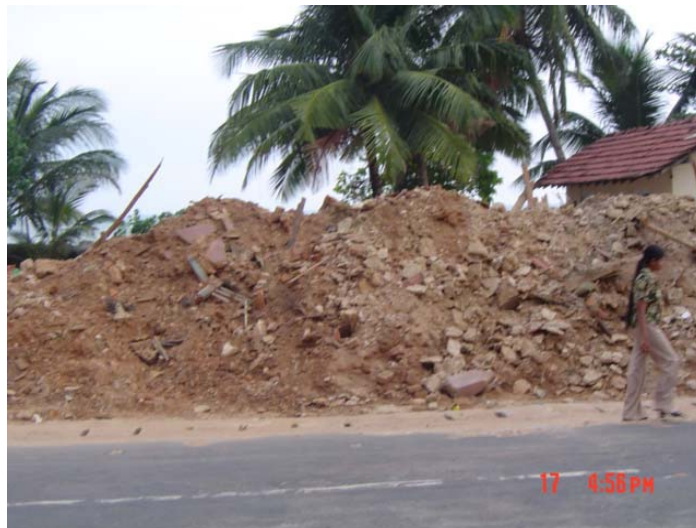
The private house of Mr. Lionel that was located at the edge of the beach was completely demolished by the waves. The foundation and the walls of this house had been constructed of limestone. The roof had been sheltered with half round tiles and the house floor was paved with clay tiles. The owner says that the house was older than 100 years.

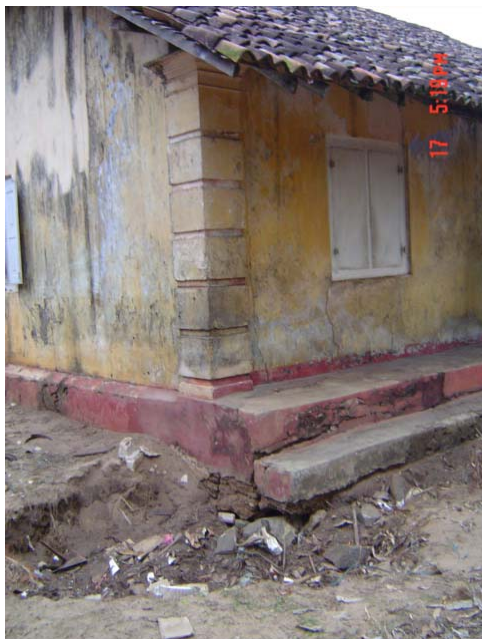
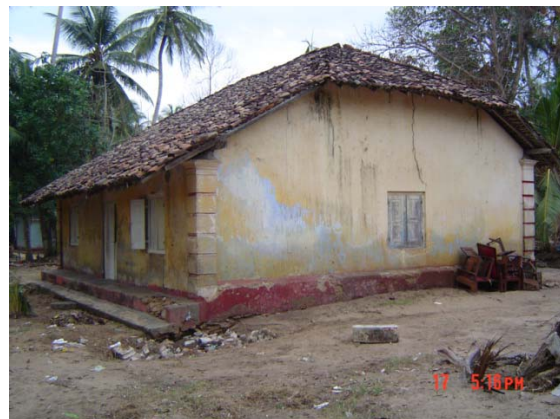
NO: M/D/KO/86

This house is situated about 120 meters inland. Pre-tsunami damage due to long term decay has been aggravated by the tidal waves. The soil around the limestone built foundation is eroded and the foundation is submerged into the ground (extent of damage 50%). The walls made of limestone are also cracked (40%). Most of these cracks had been there prior to the tsunami but are now aggravated, making the structure unstable. The half round tiled roof too has become vulnerable and may fall if the walls collapse. The damage to the timber built door and windows are minimal.

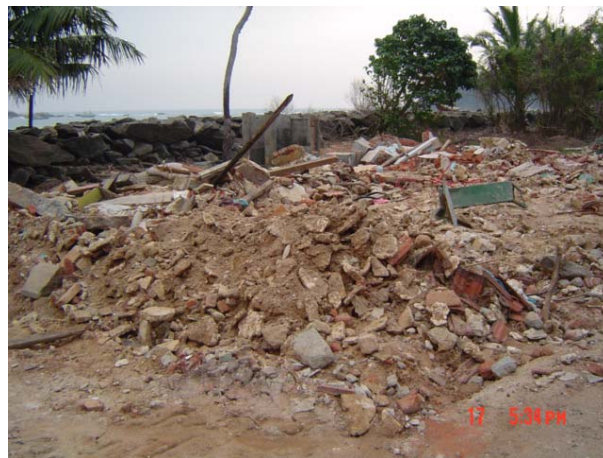
No: M/D/KO/87

The private house of K.W. P. Sunil that was situated on the beach itself is totally destroyed. The foundation and the wall had been built of limestone. Debris of the Calicut tiled roof, timber door and windows are scattered all around.

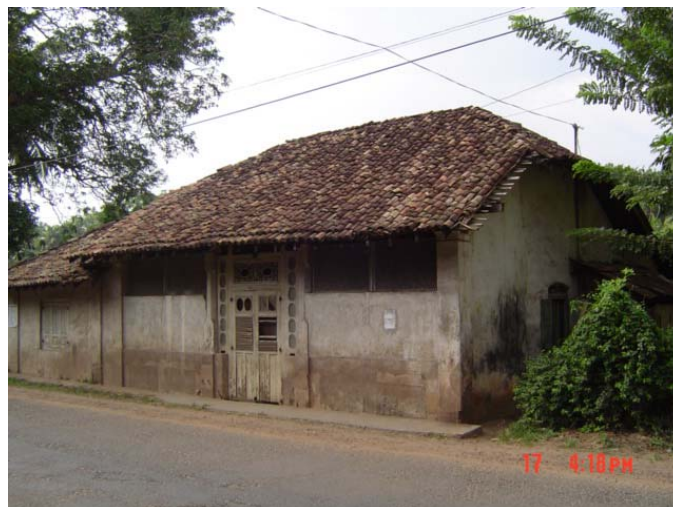
This private property situated approximately 800 meters inland is in a state of decay. The Calicut tiled roof, the walls and the timber doors and windows are decaying due to natural forces. No tsunami damage noted.

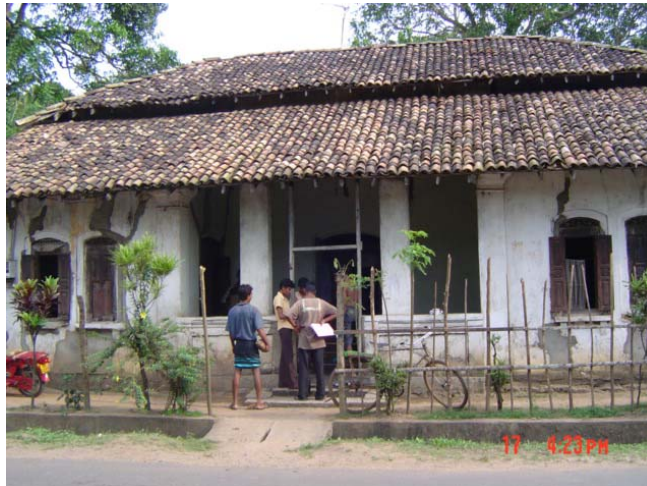
This private house clearly shows the signs of decay. It is located approximately 300 meters inland. There are two verandah rooms at each end of the square pillared narrow verandah. The timber lattice door which gives access to the verandah is destroyed.

The limestone built walls have pre-tsunami cracks. The half round tiled roof has decayed and needs to be restored immediately. The timber built doors and windows are not in very good condition. .

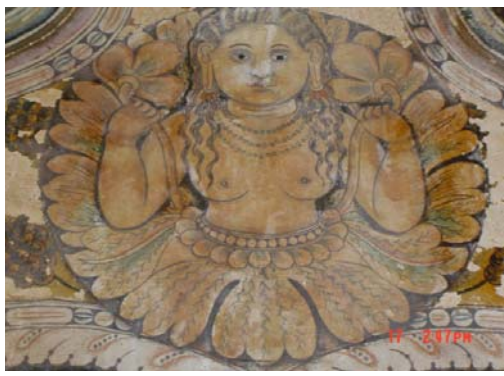
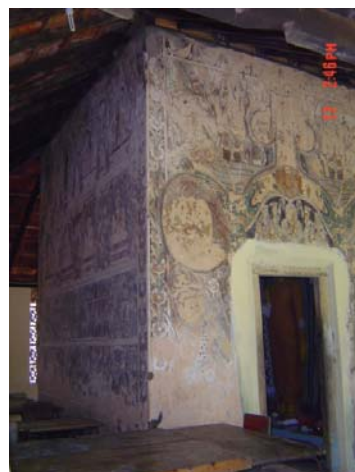
The construction materials of the foundation of this building are not known but the walls are said to have been built of limestone. The inner chamber of the image house floor is paved in ceramic tiles. The only door is timber.
