The Great East Japan Earthquake

Report
on the Damage
to the Cultural Heritage

20 November, 2011

Japan ICOMOS National Committee

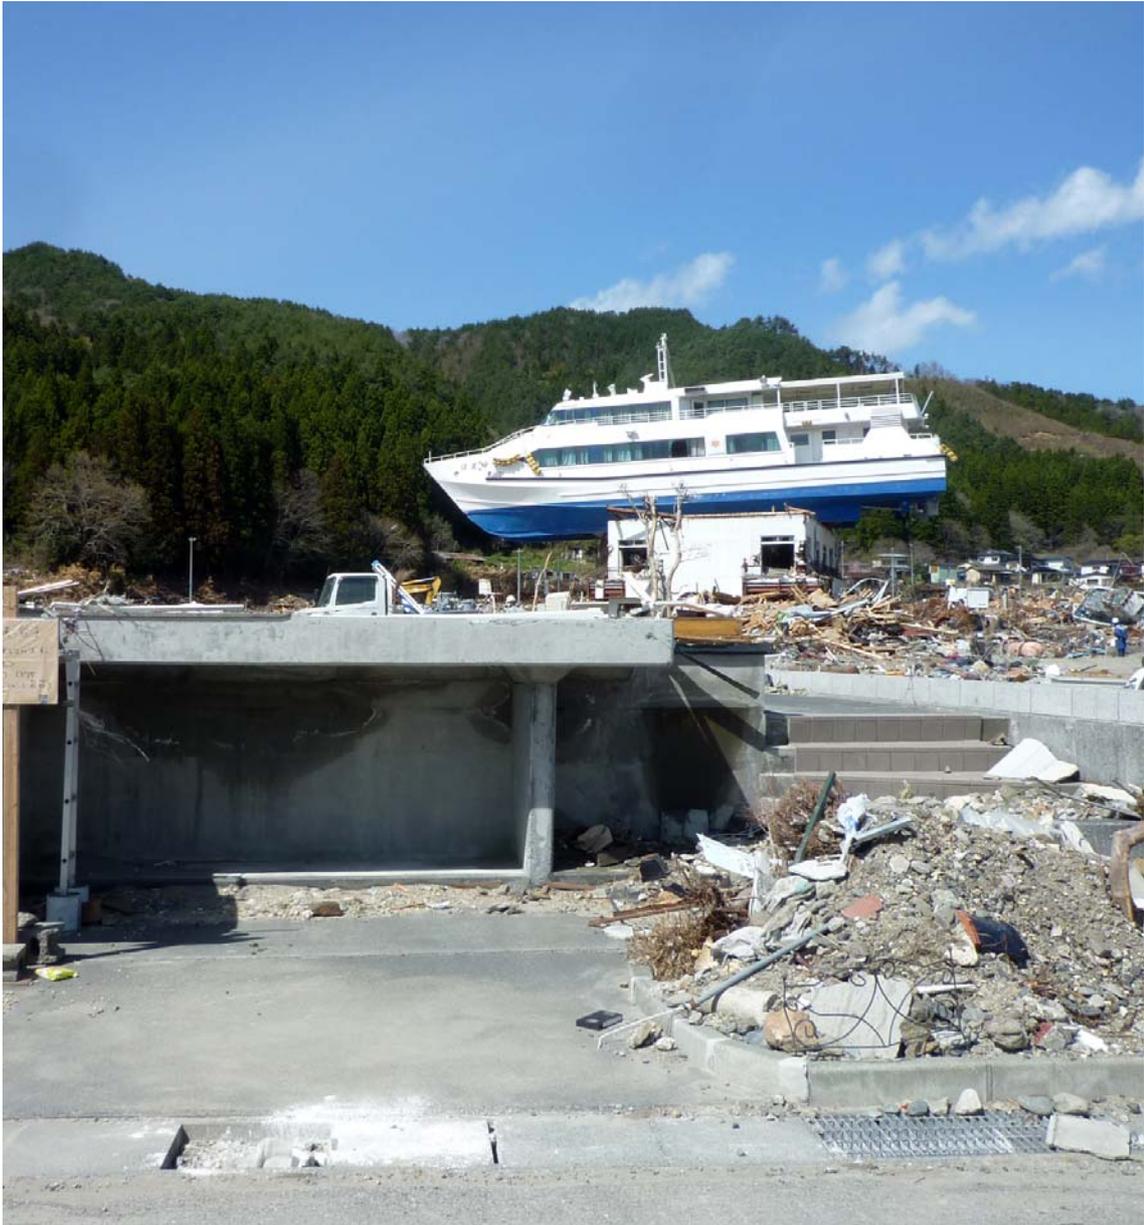
A ship washed up on the rooftop of an building by Tsunami (Ouchi Town, Iwate Prefecture)

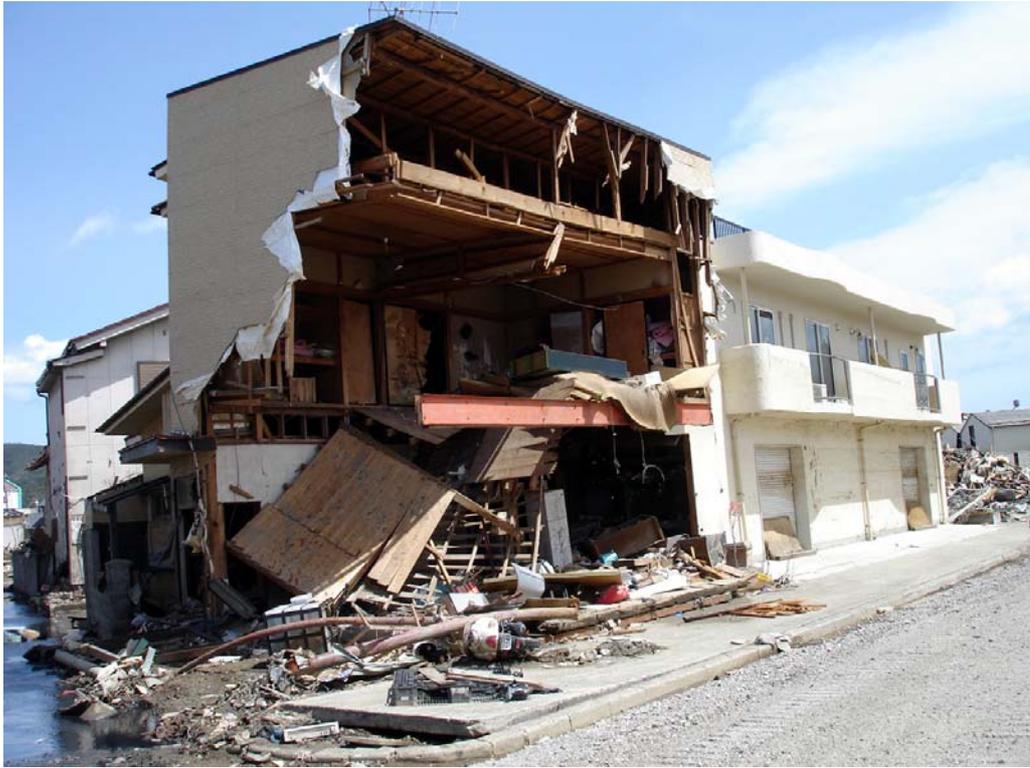
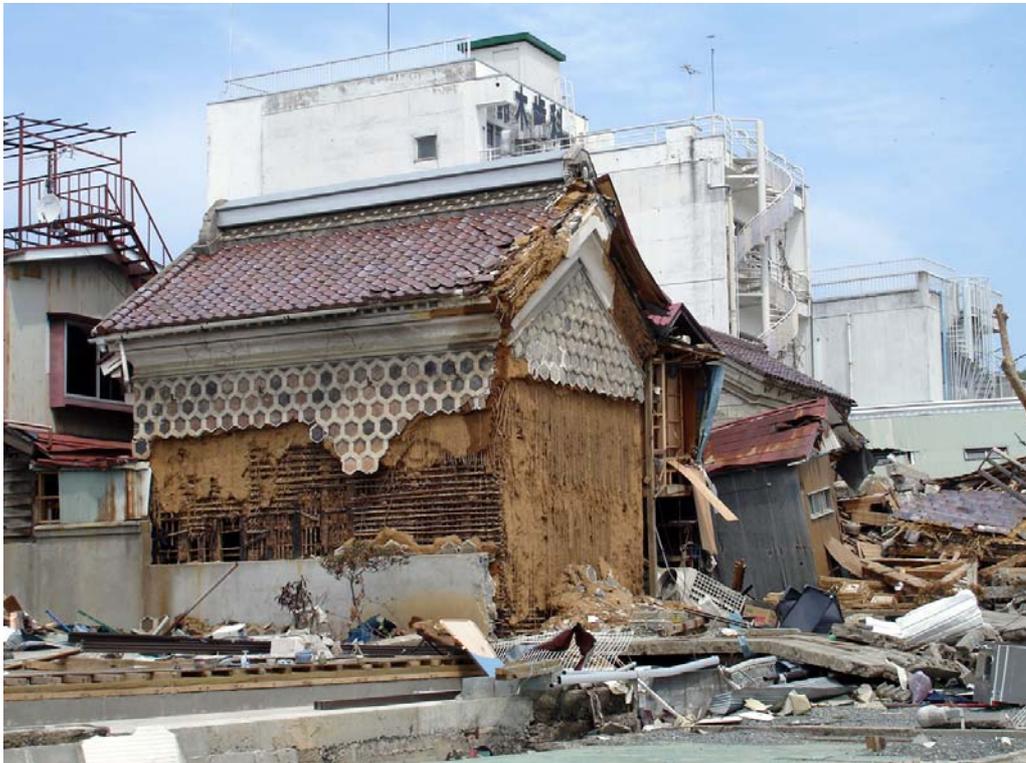
Collapsed buildings (Kesenuma City, Miyagi Prefecture)

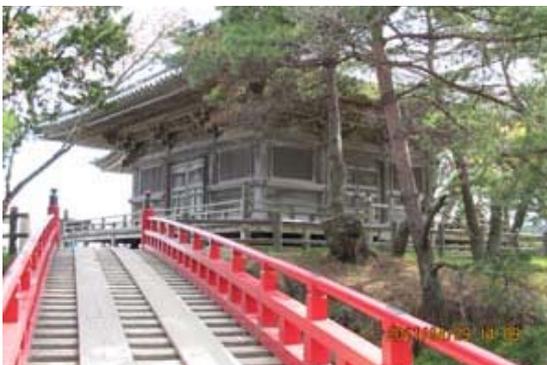
Figure 2.6 The important cultural property, Godaido, standing in the beauty spot of Matsushima: Undamaged

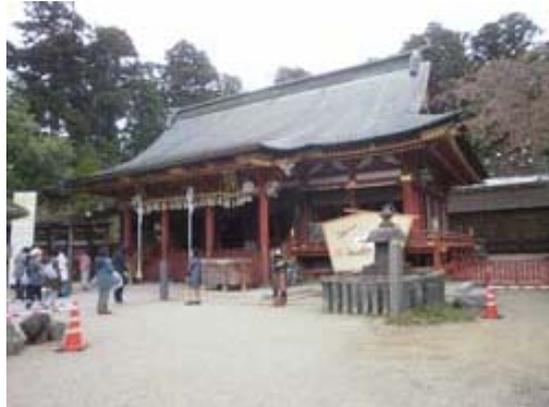
Figure 2.17 The Shiogama Shrine, an important cultural property: Undamaged

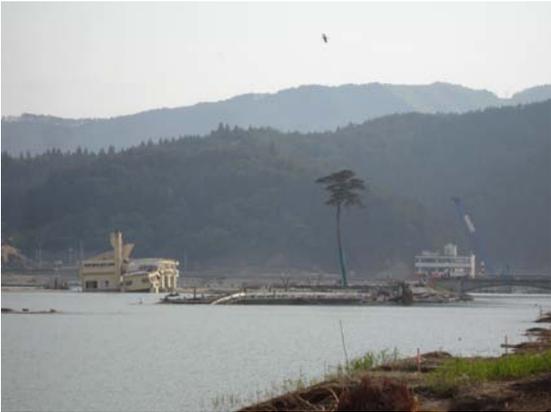
fallen pine trees are now scattered over the sandy area of the western half, which has retained its island shape. It is believed that the width of the reef from north to south has reduced to one-third following the disaster. Figure 2.34 shows, only one red pine on the western tip of the reef survived without being swept away. A three-story reinforced concrete building located in the Hirota Bay side acted as a buffer, so the red pine was able to avoid the effect of the tsunami. Accordingly, it is seen as a miracle that this red pine survived. Since the surrounding fallen trees were all shallow-rooted, it is believed that the surviving red pine has no axial root. A sand embankment was built to prevent the effect of seawater when a spring tide occurs, but the seawater came around behind the embankment and completely saturated it. As a result, the branches and leaves at the top of the pine tree are weakening. Considering that the administra-

Figure 2.34 Survived only one red pine, Takata-matsubara

tive authorities of Rikuzentakata City are temporarily incapacitated, the Iwate Prefecture Development and Promotion Bureau is endeavoring to support the conservation of Matsubara. It is seen as important to leave behind regenerated pine trees from Takadamatsubara to revitalize the area. In order to increase the number of pine trees by taking cuttings of the

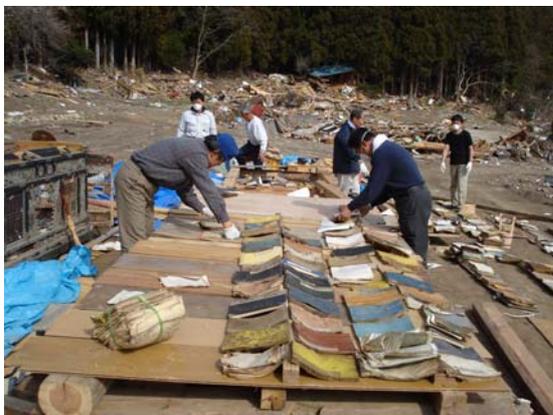
Figure 3.1 Salvage of water-damaged documents

We are still dispatching workers from the committee in response to rescue requests while taking measures to temporarily store the salvaged goods by vacuum freeze drying or washing them in order to prevent wet items from deteriorating.

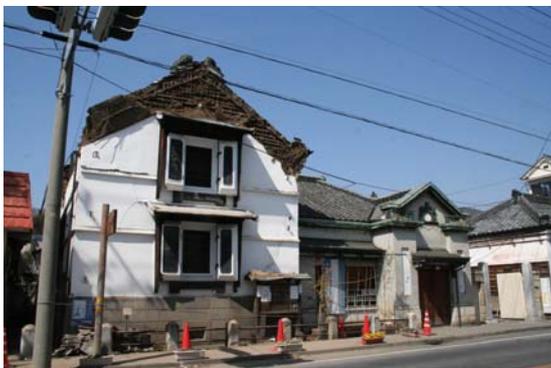
Dozo (mud-wall warehouse) buildings spreading from a wide area from Tohoku to Kanto were damaged. Figure 2.10 shows typical damage to classic *dozo* (the registered tangible cultural property, the Mori Goshi Gaisha storehouse). The eaves have collapsed and the earthen wall is cracked. Figure 2.11 is an example of damage in the Tohoku region (Sekinoichi Shuzo,

Further, damage to cultural heritage not only affected the Tohoku region, but extended over a wide range as far as the North Kanto region including damage caused by subsequent frequent aftershocks. It was reported that the majority of damaged cultural property in Kiryu City, Gunma Prefecture; which is developing a policy to establish an Important Preservation District for Groups of Traditional Buildings; was nationally-designated cultural property (of the 117 matters in 34 places, 41 matters in 17 places were affected by the disaster), and that the scale of the damage was more serious than expected (Figure 3.2).

Figure 3.2 The Mori Goshi Gaisha storehouse, a registered tangible cultural property (Kiryu City, Gunma Prefecture)

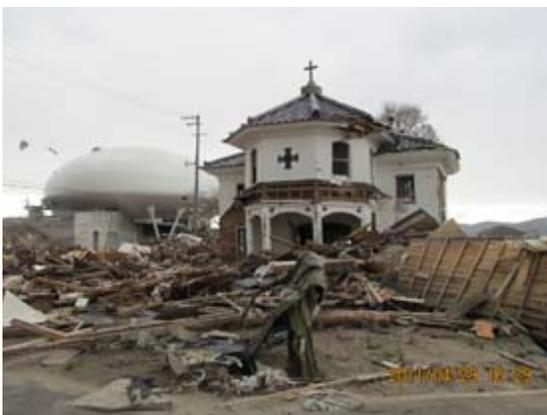
severe damage during the 1978 Miyagiken-oki earthquake (M=7.4). It has been utilized as a museum since it was relocated. The current structure employs the traditional Japanese timber framework method of utilizing braces. Before the relocation, the outer walls adopted the shitami itabari style (wooden board siding with battens), but mortar with a thickness of about 20 to 30mm is now used for finishing. Reinforced concrete is used for the strip footing and is connected well to the base of the frame. It is considered to be fortunate that since the church stands on the sandbank of the river, it might not be struck by the houses that were swept away. A combination of several factors seemed to contribute to the survival of the building. (Figure 4.1, 4.2)

Figure 4.1 Ishinomaki St. John the Apostle Orthodox Church (Ishinomori Manga Museum in the back)

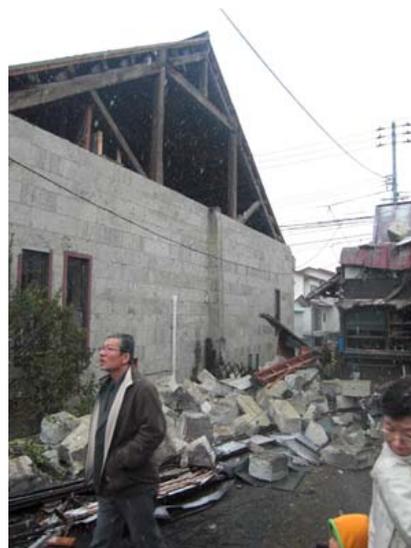
tori-kura (walk-through storehouse)). The building is slanted and the eaves are damaged. It was renovated by a *sake* brewery to be used as a *dozo*, and is a registered cultural property that was still being put to use. This heritage structure is a registered tangible cultural property and is still being put to use. Devising measures to keep utilizing it while securing safety have become a challenge. The registered tangible

Figure 4.4 External appearance of the Sekinoichi Brewery's earthen warehouse (*Torigura*)
