Name of the Monument : Talgashena Ruins
Alternative Name : Sandamini Vehera
Monument Type : *Archaeological/Historical/Religious*
Province : Southern
District : Matara
D.S. Division : Devinuwara
G.N.Division : Gandara Central
Address :

Brief Site Description:

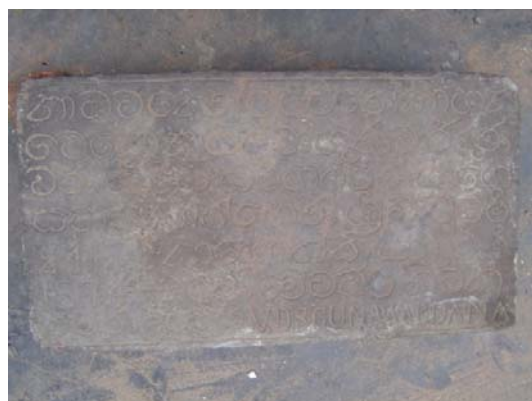
No: M/D/T/78

The site of the totally destroyed Naotunna Ambalama (the resting place) is situated about 25m by the side of the Colombo-Kataragama Road. It is located adjacent to a house cum boutique called Ulukade at Naotunna. The Ulukade itself is badly damaged due to the tidal waves.

According to Prematilleke's report the *ambalama* (24'x15') consisted of two parts: the verandah and an inner room. Even at the time of his recording, the building had been in a state of decay despite several apparent renovations.

It is clear from the rubbles and residue of the foundation and the walls of the building that it had been constructed of limestone. The walls and the roof had been made of half round tiles. According to the owner of the Ulukade (Ulukade Vedamahata), aged about 60 years, the binding material/ mortar of this building was made of banana, honey and limestone. During his childhood there had been a stone water pot (*pantaliya*) filled with water for the use of passersby. No trace of this could be found and the informant himself was clueless about its whereabouts. It had gone out of use and gone missing prior to the tsunami tidal waves.

Level of Intervention : **Totally Destroyed (100%)**
Estimated Cost for the Conservation : **NA**
Location Map/GIS Coordinates : **Map-i/M/D/T/78**

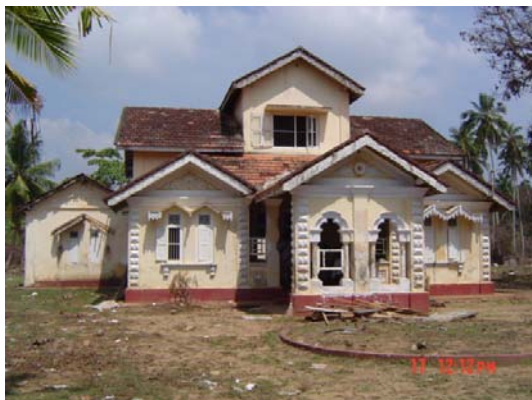
No: M/D/T/79

This house which has architectural affinities to both Dutch and British traditions is located about 300 meters inland. The interior of the house is approached by a portico and a verandah. There are two rooms at each end of this verandah. A timber mezzanine makes the *zaal* and the adjacent rooms a two storied building. A timber staircase facilitates access to the first floor. There is a round pillared and half walled verandah in the rear of the house. A row of wing rooms extend to the backyard at the right side. Brick walls have pre-tsunami minor cracks and bear slight plaster damage. The Calicut tiled roof is in good condition. The cement rendering floor bears some damage but not due to the impact of the tidal waves. The damage to the timber doors are about 50%. The timber lattice work in the front verandah and the portico is destroyed, but prior to the waves.

Level of Intervention : Significant Level of Intervention (10-30%)
Estimated Cost for the Conservation : Rs. 110,000
Location Map/GIS Coordinates : Map-i/M/D/T/79

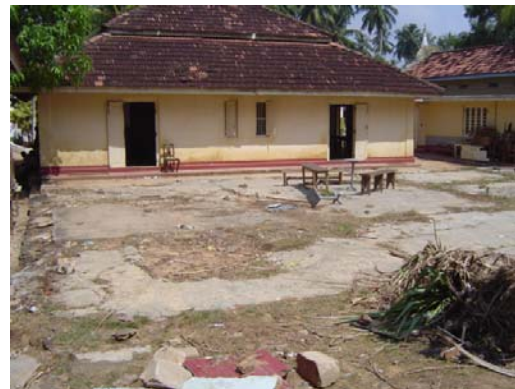
NO: M/D/NS/80

Though situated on the beach itself, this monastery has received only minimal intervention by the waves. It was built in 1910. However, the oldest building of the temple had been destroyed prior to the tsunami. The *dharmasala* and other buildings are from much later periods. There is some minor damage to the doors of the *dharmasala*, but not of any architectural /archaeological significance.

Level of Intervention : Minimal Level of Intervention(0– 10%)
Estimated Cost for the Conservation : NA
Location Map/GIS Coordinates : Map – i/ M/D/Ns/80

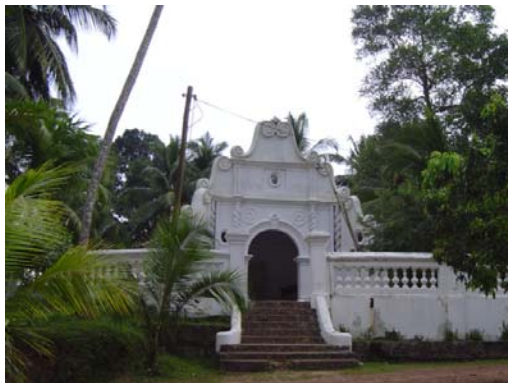
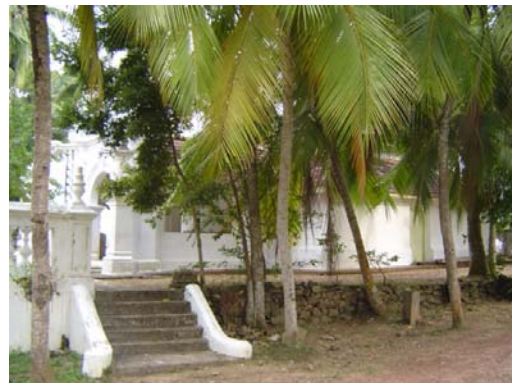
This monastery is situated about 300 meters from the sea. The tsunami tidal waves did not enter the *vihara* premises. There are a few stone pillars around the *stupa* and an old bell tower in the *vihara* premises. However, the most significant monument in the temple is the oldest *vihara*. Nevertheless, admission to the image house was denied as the high priest was away. However, late Kandyan period paintings in the *vihara* were observed through an opening in the door. The date of the construction and the renovations are inscribed below the dragon pandol - the *makara torana* in the *vihara*. They are 2443 and 2492 Buddhist era. The roof of the *vihare* is of half round tiles while the doors and the windows are made of timber.

Level of Intervention : Minimal Level Intervention (0-10%)
Estimated Cost for the Conservation : NA
Location Map/GIS Coordinates : Map-i/M/D/L/88

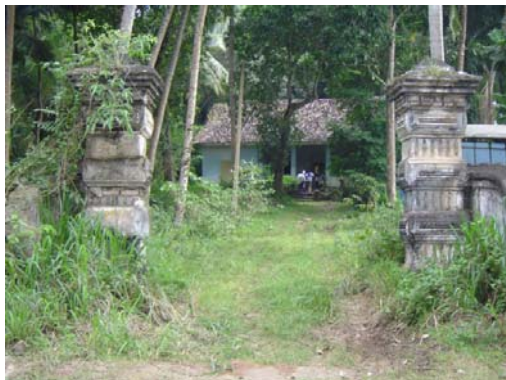
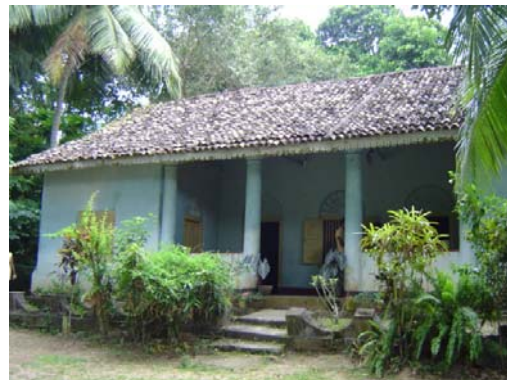
No: M/D/L/89

Kulatilaka Walawwa now in a state of decay is situated about 700 meters inland and tsunami waves did not reach this area.

The structure bears original Dutch architectural characteristics. The round columned verandah in the front has two verandah rooms at each end. Two main doors facilitate access to the inner house. The columns, the garge boards (*vadimbu*), the wall decorations above the doors and windows indicate its affinity to Dutch architecture. The foundation and the walls are built of limestone; whereas the roof is sheltered in half round tiles and is in a state of decay. Doors and windows are made of timber. The floor is cement rendered. The owners claim a history of over 100 years for the construction of the house.

Level of Intervention : Minimal Level of Intervention (0-10%)
Estimated Cost for the Conservation : NA
Location Map/GIS Coordinates : Map-i/M/D/L/89

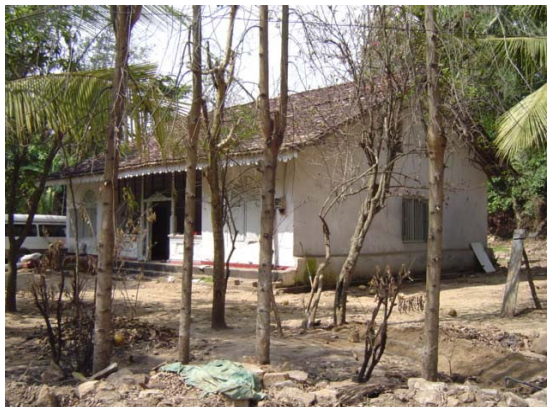
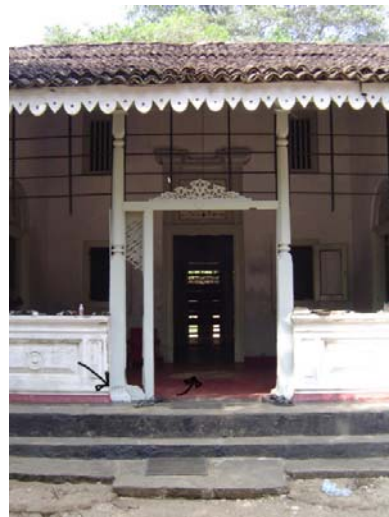
The foundation is constructed of rubble while both limestone and rubble are used for the walls. The house is roofed in half round tiles. The house floor is made up of cement rendering, clay tiles and granite. The doors and windows are of timber. The front verandah had timber lattice work above the short brick walls. The lattice work is completely destroyed.

As in many typical buildings of Dutch architectural character, there is a timber mezzanine above the *zaal* and a bedroom. The pre-tsunami cracks on the walls have been aggravated by the force of the tidal waves and in some places plasters has come off the wall. The kitchen in the back of the house of which the walls had been constructed of wattle and daub is badly damaged.

The timber doors and windows have also been badly damaged or totally destroyed. The boundary wall is completely destroyed. Though no apparent danger of collapse is visible in the structure, steps should be taken to restore the building. Some of the doors and windows are totally destroyed while others are badly damaged.

Level of Intervention : **Substantial Level of Intervention (30-60%)**
Estimated Cost for the Conservation : **Rs. 276,000.00**
Location Map/GIS Coordinates : **Map-i/M/D/B/96**

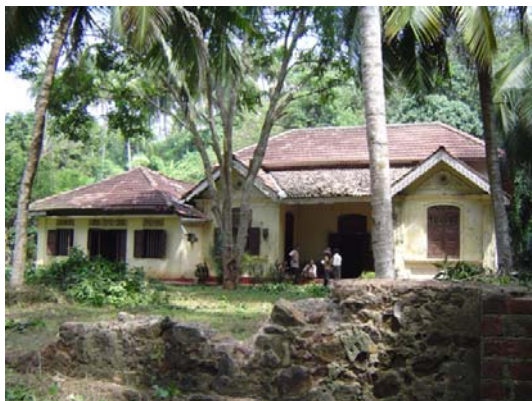
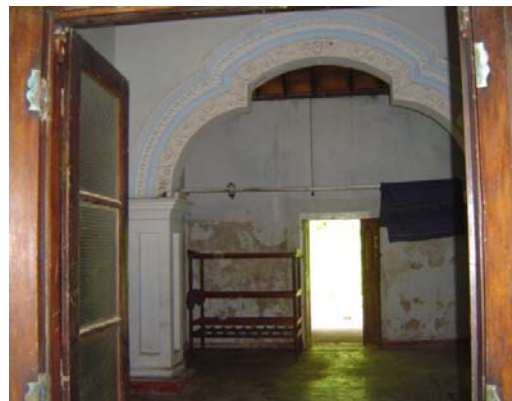
The foundation is not visible and the building material is unknown. The walls are built of both limestone and the sun burnt bricks. The roof is sheltered in both varieties of tiles: Calicut and half round. The roof is severely decayed due to the impact of natural forces. There were no tsunami influences on this property.

Level of Intervention : **Minimal Level of Intervention (0% - 10%)**
Estimated Cost for the Conservation : NA
Location Map/GIS Coordinates : **Map-i/M/D/Di/98**

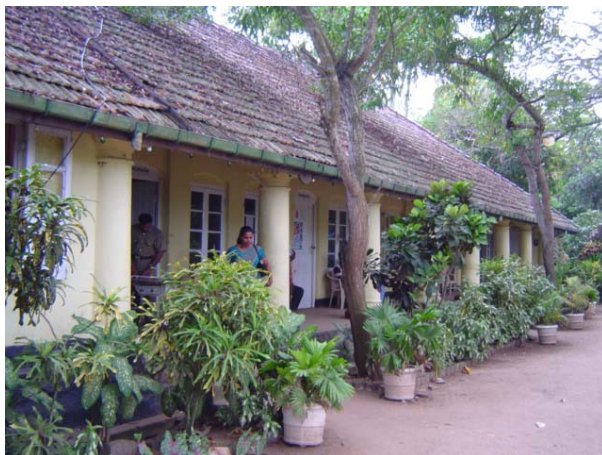
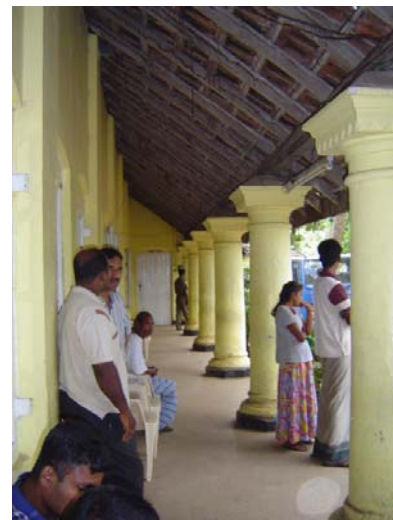
The building material of the foundation and the walls is said to be rubble and limestone. This building is sheltered with Calicut tiles and the floor is cement rendered. The doors are timber while the windows are of timber framed glass. The structure is in good condition and was not affected by the waves.

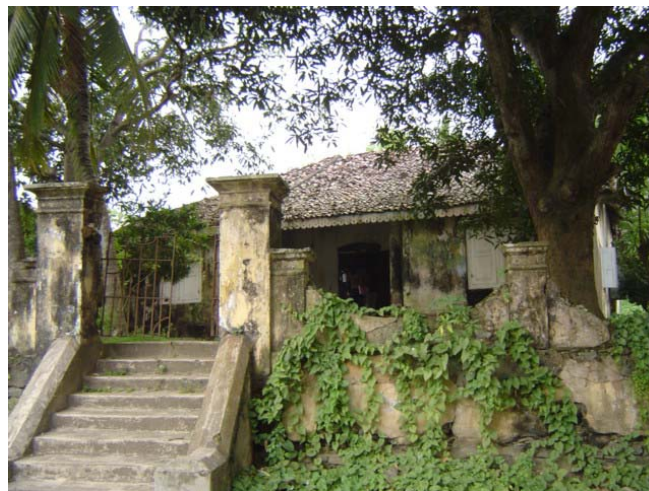
This structure is situated about 120 meters from the sea and on much higher ground. Therefore, it did not get affected by the tidal wave action. However, this Dutch styled building is in a state of decay. The foundation of the house is built of limestone. The brick built walls show signs of decay due to exposure to the weather and are severely damaged (50%). The wall plaster is very fragile and comes off the walls. The cement rendered house floor too is not in very good condition. The half round tiled roof is damaged (50%).

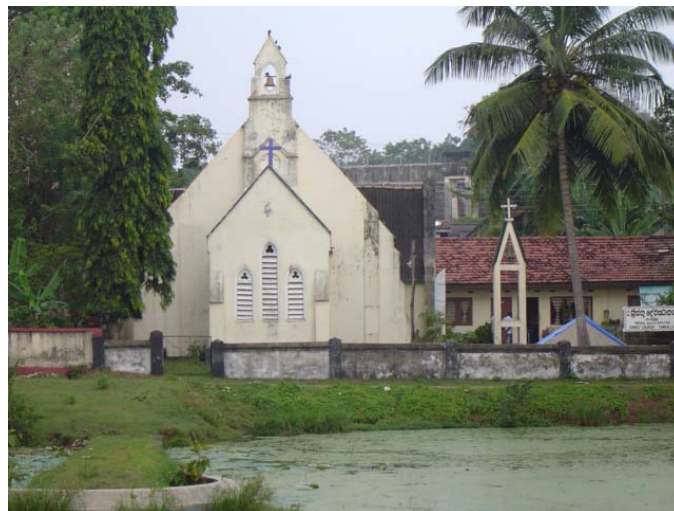
The construction material of the foundation and the walls are unknown. The floor is of clay tiles and the roof is asbestos. Windows are of timber paneled glass, while the doors are of timber. This structure was not affected by the tidal waves but urgent attention is required.

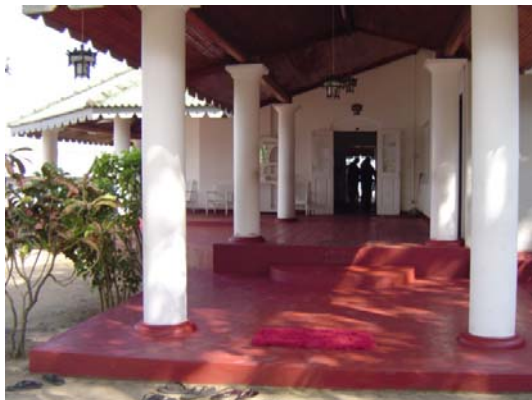
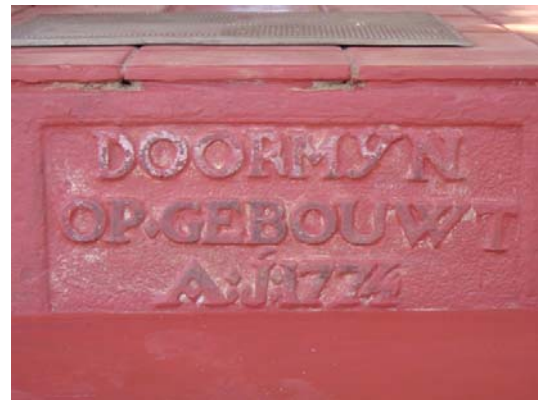
The construction material of the foundation is not known, but the walls, of which the plaster is totally re-done, is built of brick. The floor is paved with clay tiles; but it is not clear whether they are original or not. The round colonnaded spacious verandah of the old wing seems to have retained its original character too. The half round tiled roof is replaced by asbestos.

The timber framed glass windows were damaged, but they had been repaired even before this study. The boundary wall is completely destroyed.

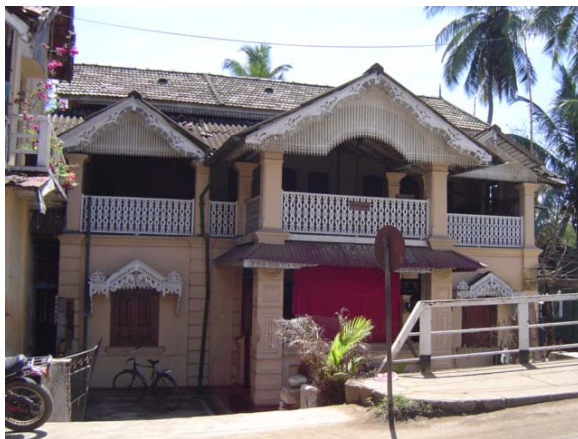
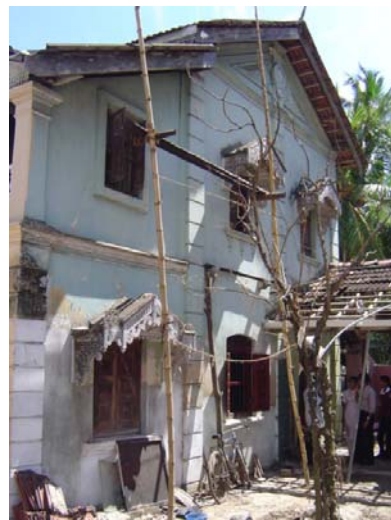
The foundation of the buildings is built of rubble, while the walls are of brick. Walls are in good condition and not damaged by the waves.

The Calicut tiled roof is in good condition but a part of the rear side roof was damaged by the tidal waves (20%). The ground floor is cement rendering, whereas the 1st floor is a timber mezzanine. Timber door and timber framed windows are unharmed by the waves. The owner was very keen on commencing the repair work. This building needs urgent attention.

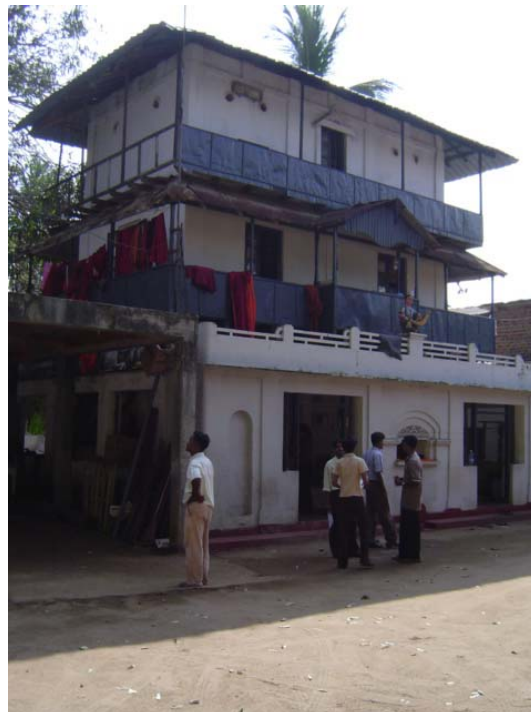
This temple is situated about 550 meters inland from the sea near the Tangalle Bridge. According to Prematilleke, this temple is only 15 years old. The temple was established in 2466 Buddhist era. No tsunami damage to any of the monuments of archaeological importance was noted.

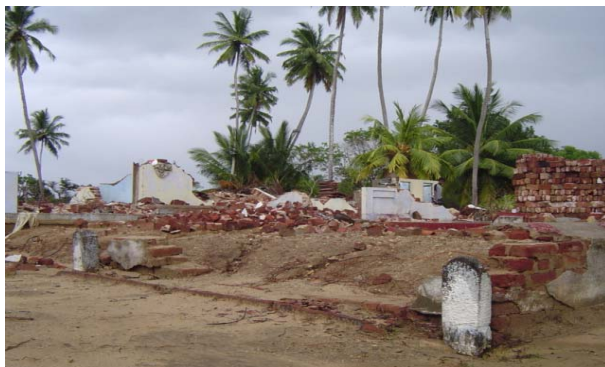
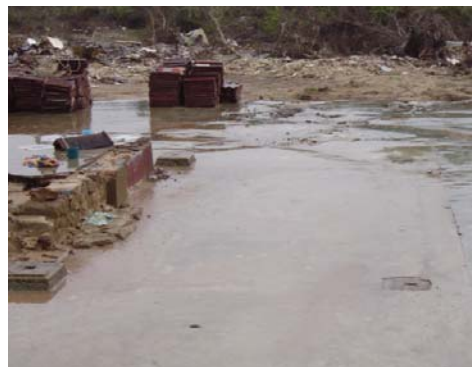
It is clear from the remains that the foundations and the walls of this building had been constructed of limestone while the half round roof tiles that were originally used for the roof had been replaced by Calicut tiles 2 years ago. The chapter house area is demarcated by erecting eight stone slabs around the building. They are about 1 foot above the ground level and are inscribed in Sinhala: "Tilakaratanaramaya Chapter House 1815", this date could be taken as the year of the construction of this building. What remain now of this building are only the foundation and the stone pillar bases with slots in the center which held the timber posts of the walls.

The foundation of the completely destroyed preaching hall is situated immediately to the west of the chapter house. According to the chief incumbent and the villagers, the roof tiles of the *dharmasala* had been dated 1862 - the manufacturing date. The foundation and the walls of this building were built of limestone. The half round tiles of the roof had been replaced by Calicut tiles two years ago. Stone pillar bases similar to those of the chapter house are found here too.

The foundation of the totally destroyed *vihara* is comparatively of a much later period. It is situated a few meters north of the two buildings mentioned above. The *vihara* consisted of an inner shrine room with an outer room around it – a double chambered shrine room.

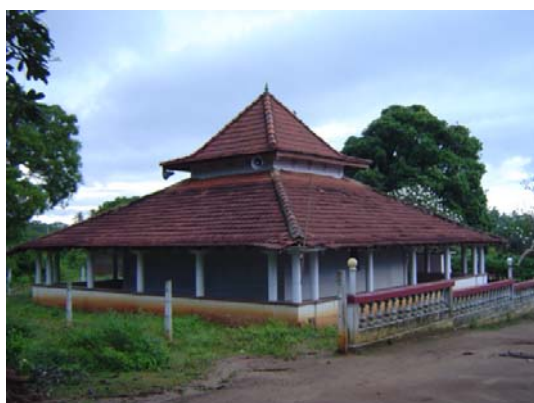
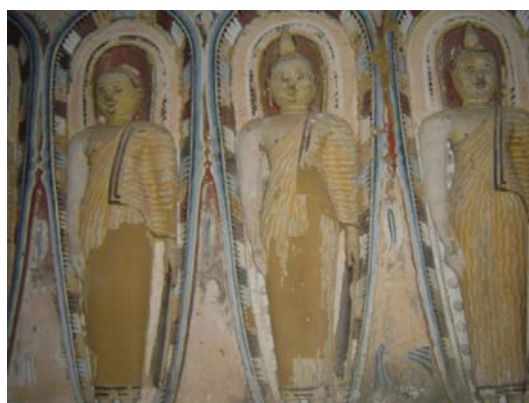
This temple is situated about 200 meters from the sea. The tsunami waves did not reach the temple. The *vihara* is the only important structure in the context of the present study, but we did not have access as the monk was not there. However, the painting could be seen through open windows and they are of the maritime style of the Kandyan tradition. The Buddha statues of the 19th century Kandyan style are in a state of decay. The roof of the image house that contains the paintings and the statues has been renovated recently. There are stone object similar to *pantali* near the Bodhi tree.

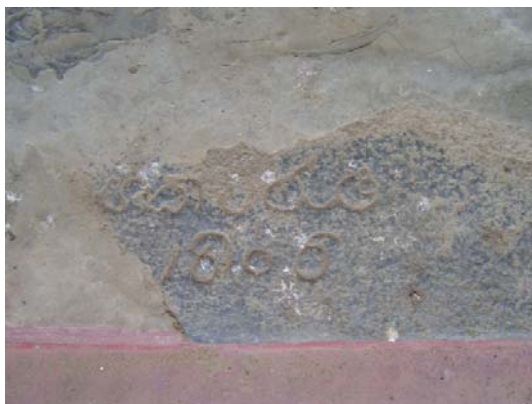
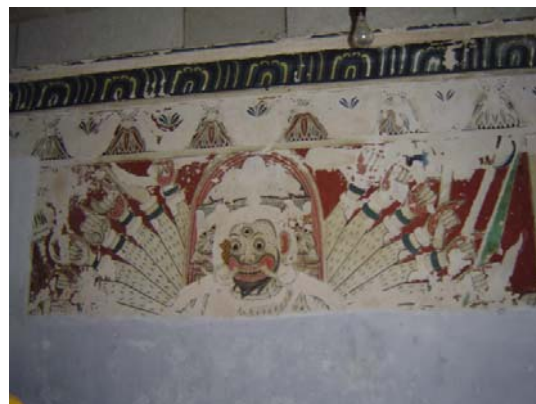
This temple is located about 200 meters from the sea. Prematilleke dates the founding of this temple to the early part of the 19th century. The chief monk claims that this was built in 1850 and a doorstep at the entrance to the *vihara* has an inscribed date of 1806 in the Saka era.

The *vihara* is the only structure of interest to us. This structure is unharmed by tidal wave action. It contains 19th century paintings in the maritime style. Most of the paintings of this tradition are destroyed due to decay and there have been attempts to preserve them.

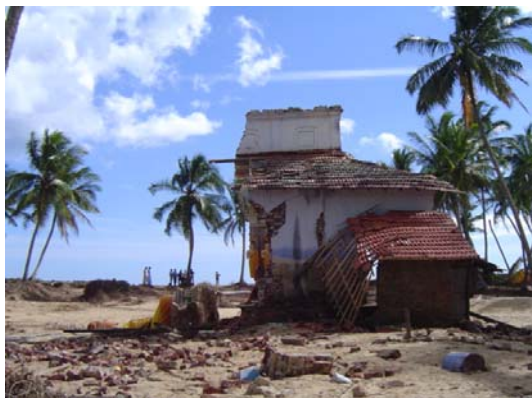
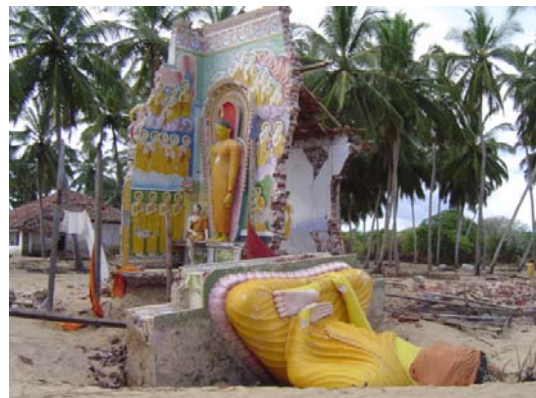
The *Gangaramaya* has two culturally and archaeologically important buildings which are situated about 30 to 35 meters from the sea.

Though Prematilleke dates this *vihara* to 1951, the present chief monk claims a much older date. The wall paintings of the remaining portion of the *vihara* indicate an older date. The building was constructed of brick and roofed in Calicut tiles. The floor had been cemented. The image house is completely destroyed except for parts of the painted walls facing the sea. The standing Buddha statue built against this wall is unharmed. A huge seated Buddha statue facing west is dislocated and has fallen. It is covered with a robe but no apparent damage has happened to it. The monk says the Buddha statues are never built facing west as it brings misfortune to the temple and the village. According to him that is why this statue is displaced but remains unharmed. The standing Buddha built in keeping with the tradition remains intact.

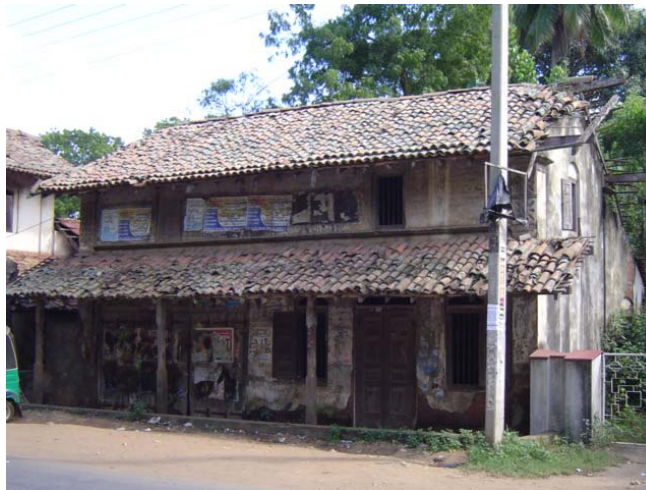
This structure is situated about 2 km inland on the opposite side of the Girihandu Saya near the Ambalantota Bridge. The tsunami water did not reach this area. The structure could only be observed from outside. This double storied building, probably with a timber mezzanine is roofed in half round tiles. This is severely deteriorated. There is a timber pillared verandah in the front, probably; a construction of the early twentieth century.
